NOTICE OF INTENT TO ADOPT A NEGATIVE DECLARATION

PROJECT: Sunland Garden Products

PROJECT DESCRIPTION: The project is a proposal to construct a 9,900 square foot non-habitable enclosure over an existing soil mixing operation (Sunland Garden Products). The project intends to address issues pertaining to noise and dust by way of enclosing portions of an existing soil mixing line and address stormwater quality issues by way of installing comprehensive stormwater management plan for the project site.

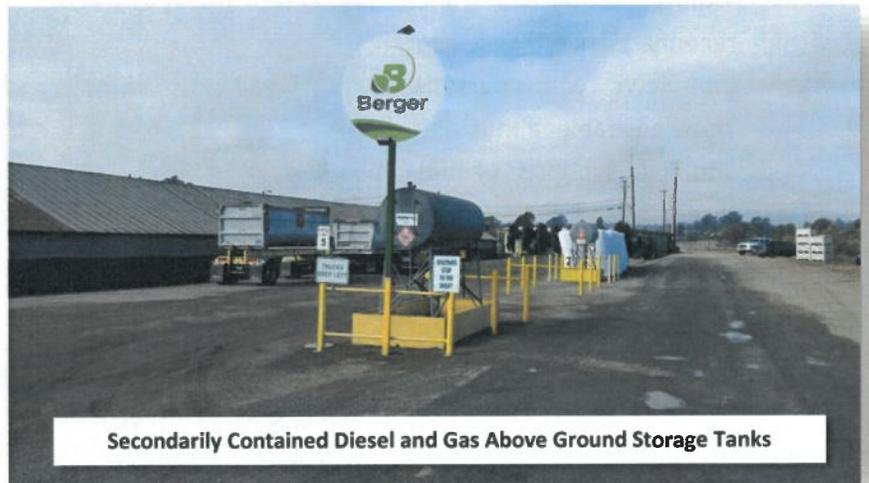
Secondarily Contained Diesel and Gas Above Ground Storage Tanks

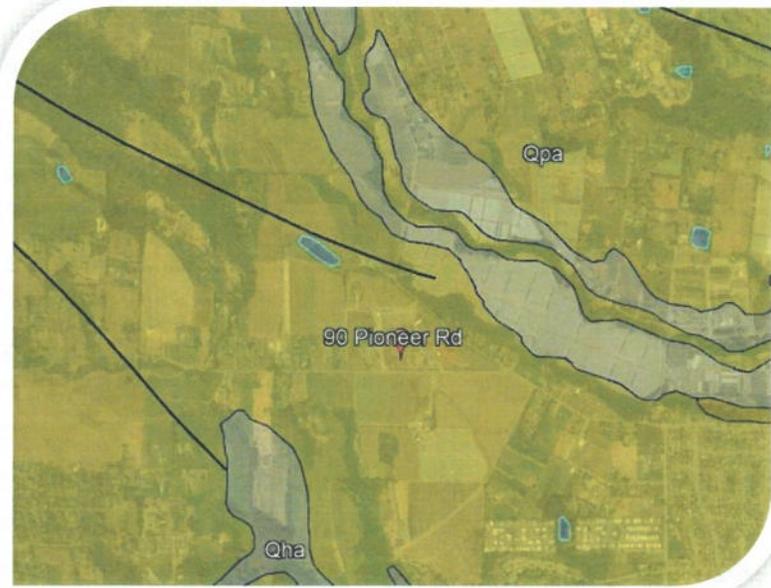
Regional Geologic Map:
Qpa: Alluvium (Pleistocene) underlie the subject site.

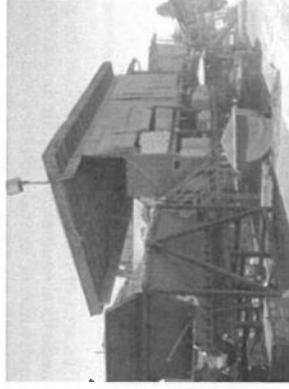
4.1.1 Mix Lines 1 and 2

Potential Pollutants	Sources
Total Suspended Solids (TSS)	Redwood Bark, Coir, Peat Moss, etc.
Oil and Grease (O&G)	Leaks from trucks, forklifts, or mechanical equipment

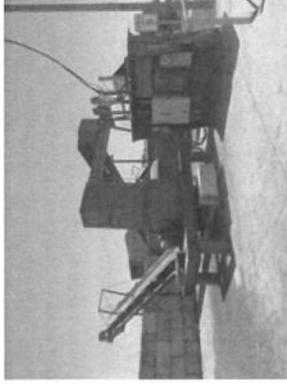
4.1.2 Grinder

Potential Pollutants	Sources
Total Suspended Solids (TSS)	Redwood Bark, Coir, Peat Moss, etc.
Oil and Grease (O&G)	Leaks from trucks, forklifts, or mechanical equipment

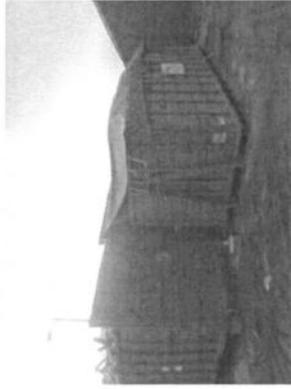
4.1.3 Metal Bin Storage

Potential Pollutants	Sources
Iron (Fe)	Rust from metal bin leakage
Nitrate and Nitrite (N+N), Phosphorous (P)	Residues from fertilizer bags in metal bin leakage

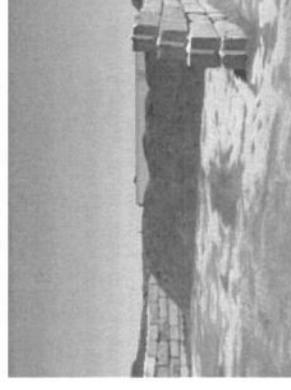
4.1.4 Lava Rock and Coir Storage

Potential Pollutants	Sources
Total Suspended Solids (TSS)	Lava rock and coir debris tracked out of bins
Oil and Grease (O&G)	Leaks from trucks, and forklifts

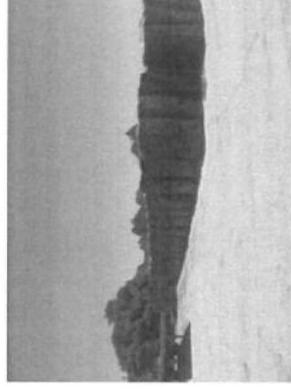
4.2.2 Materials Storage

Potential Pollutants	Sources
Total Suspended Solids (TSS)	Sediment from unpaved driveways and storage areas
Oil and Grease (O&G)	Leaks from trucks, and forklifts

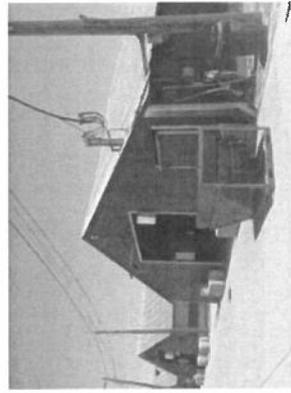
4.3.1 Buildings 1 and 2 - Bagging

Potential Pollutants	Sources
Total Suspended Solids (TSS)	Tracked out debris from bagging operations
Oil and Grease (O&G)	Tracked out leaks from equipment and forklifts

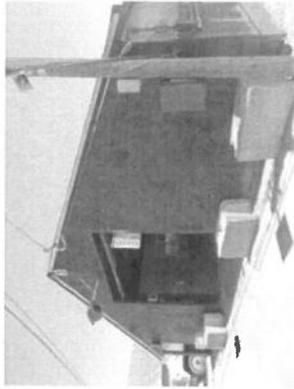
4.3.2 Buildings 3 and 4 – Fertilizer and Coir Storage

Potential Pollutants	Sources
Total Suspended Solids (TSS), Nitrate and Nitrite (N+N), Phosphorous (P)	Tracked out debris from leaks and spills of fertilizer
Oil and Grease (O&G)	Tracked out leaks from trucks and forklifts

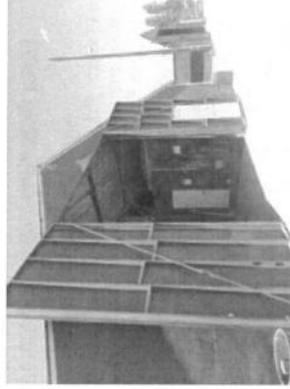
4.3.3 Building 5 – Mechanics Shop

Potential Pollutants	Sources
Oil and Grease (O&G), Zinc (Zn), Iron (Fe)	Tracked out leaks and spills of new oil/fluids, residues, and particulates

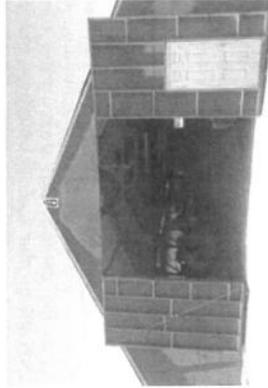
4.3.4 Building 6 – Maintenance Shop

Potential Pollutants	Sources
Oil and Grease (O&G)	Tracked out leaks and spills from equipment

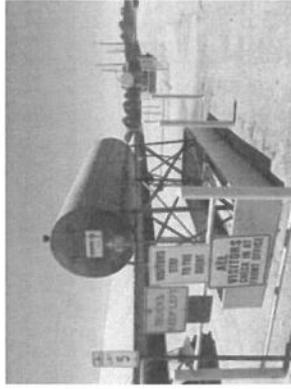
4.3.5 Truck Fueling – Above Ground Storage Tanks

Two above ground storage tanks (ASTs) are located north of Building 6. This area is used for AST storage and dispensing of fuel to trucks and loaders. The gasoline AST is 250 gallons, and the diesel AST is 500 gallons. Both ASTs are located over secondary containment. An additional 250 gallon AST containing diesel is located south of the staging area. This AST used for equipment fueling is located in a storm resistant shelter with secondary containment. All fueling operations are performed outdoors and are potentially exposed to storm water. Storm water received in these drainage areas is conveyed south via sheet flow to storm water channels or drain inlets which discharge to Sedimentation Basin 2.

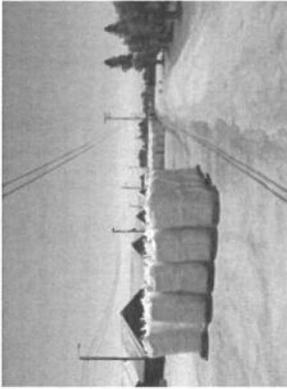
4.3.6 Materials Staging and Peat Moss Storage

Potential Pollutants	Sources
Total Suspended Solids (TSS)	Sediment from unpaved driveways/aisles
Oil and Grease (O&G)	Oil/fluid leaks from truck and forklifts

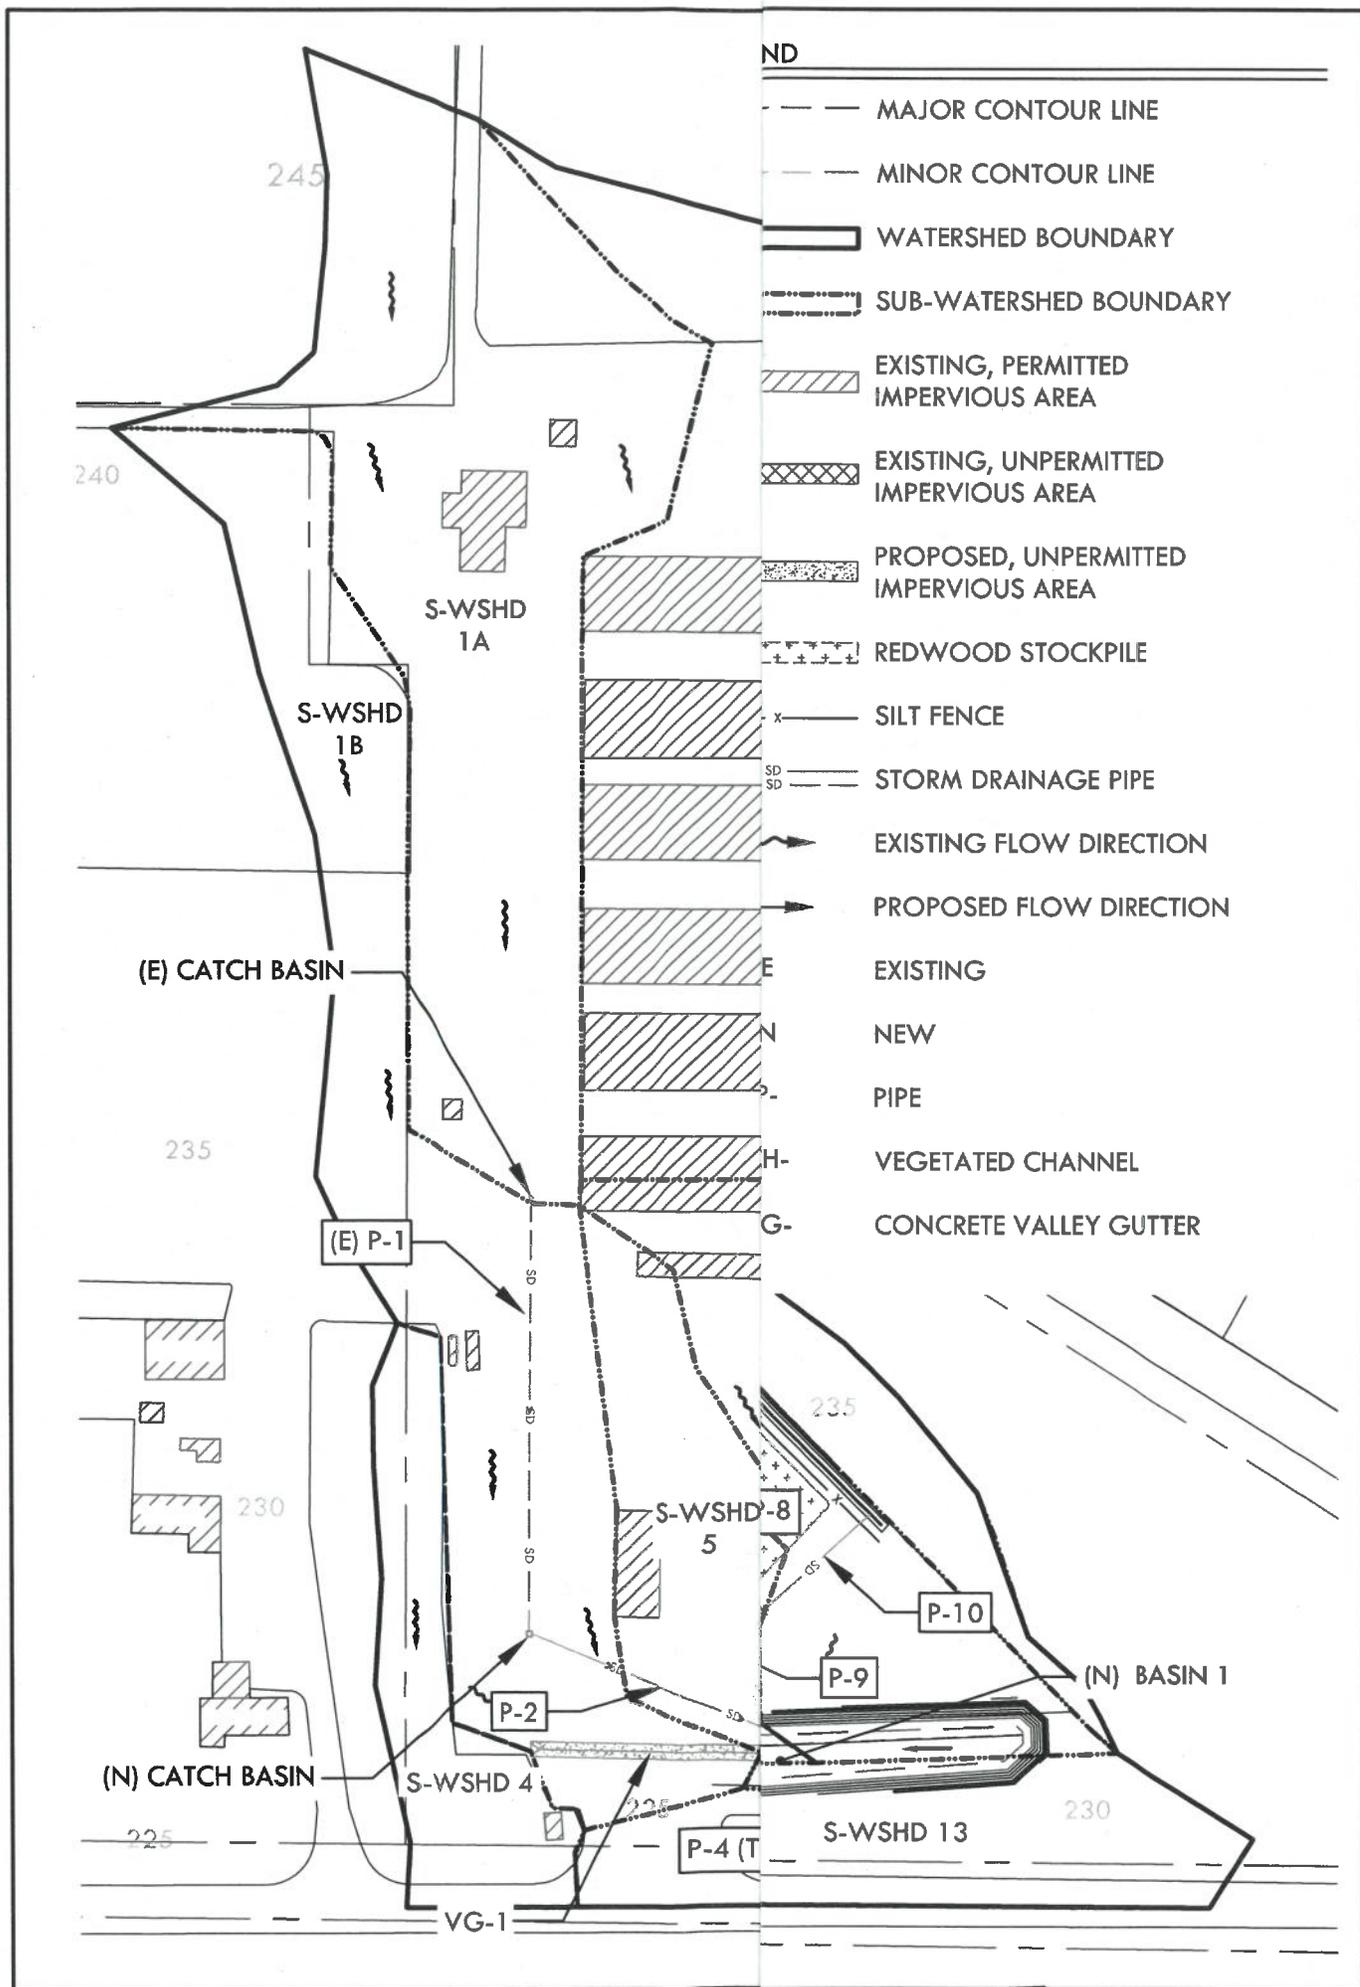
FIGURE 1: OVERALL WATERSHED, SUB-WATERSHEDS AND RECIPIENT MITIGATION FEATURES

Sub-Watershed Area	Receptient Flood Control Mitigation(s)	Pollutants of Concern
7	--	n/a
8	P-9 P-10 CH-11	TSS
		Nitrogen
		Phosphorus
9	P-9 CH-10	TSS
		Nitrogen
		Phosphorus
10	P-8	TSS
		Nitrogen
		Phosphorus
11	P-7 CH-8 CH-9	Iron
		Nitrogen
		Phosphorus
		Oil and Grease
12	P-14 P-16 W-1	Iron
		TSS
		Nitrogen
		Phosphorus
13	P-15	Oil and Grease
		TSS
		TSS
		TSS
14	--	TSS
		TSS
		TSS
		TSS
15	P-4 CH-1 CH-2 CH-3 CH-4	TSS
		Nitrogen
		Phosphorus
		Oil and Grease
16	CH-5 CH-6 CH-7 CH-12	TSS
		Nitrogen
		Phosphorus
		Oil and Grease
17	P-12 P-16	TSS
		Oil and Grease

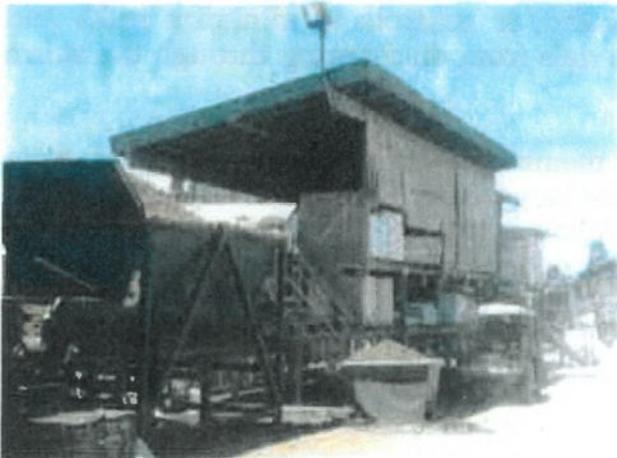
4.1.1 Mix Lines 1 and 2

Potential Pollutants	Sources
Total Suspended Solids (TSS)	Redwood Bark, Coir, Peat Moss, etc.
Oil and Grease (O&G)	Leaks from trucks, forklifts, or mechanical equipment

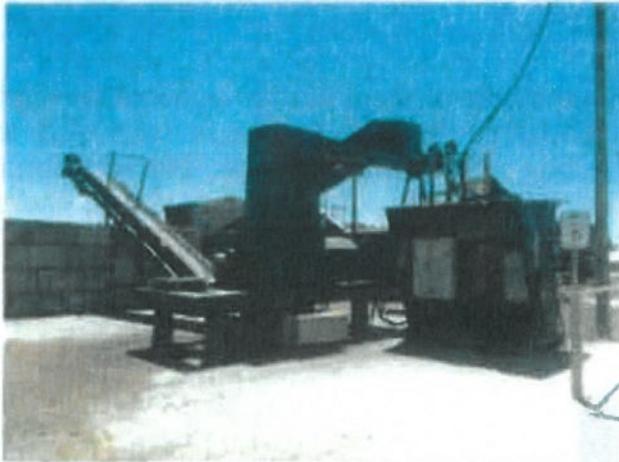
4.1.2 Grinder

Potential Pollutants	Sources
Total Suspended Solids (TSS)	Redwood Bark, Coir, Peat Moss, etc.
Oil and Grease (O&G)	Leaks from trucks, forklifts, or mechanical equipment

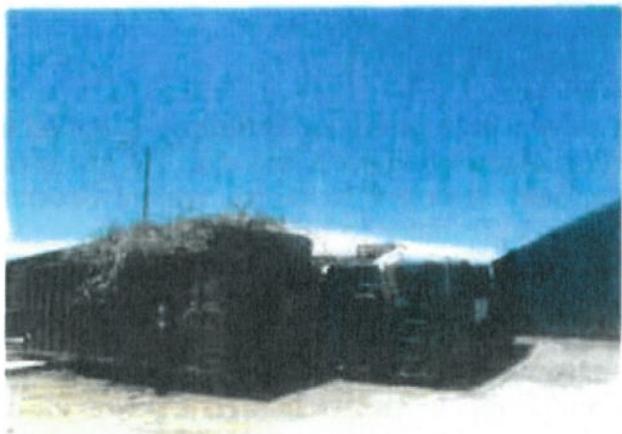
4.1.3 Metal Bin Storage

Potential Pollutants	Sources
Iron (Fe)	Rust from metal bin leakage
Nitrate and Nitrite (N+N), Phosphorous (P)	Residues from fertilizer bags in metal bin leakage

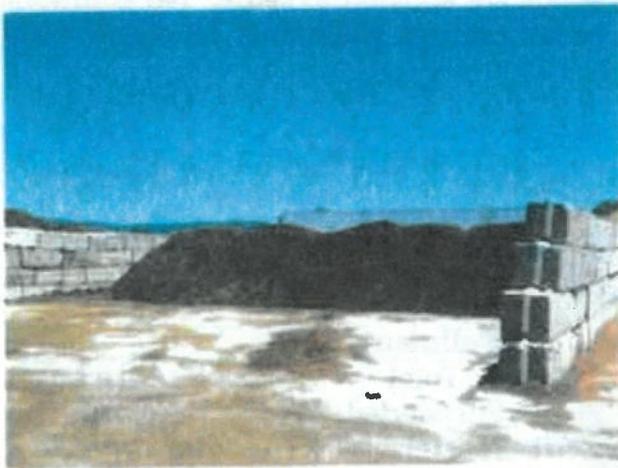
4.1.4 Lava Rock and Coir Storage

Potential Pollutants	Sources
Total Suspended Solids (TSS)	Lava rock and coir debris tracked out of bins
Oil and Grease (O&G)	Leaks from trucks, and forklifts

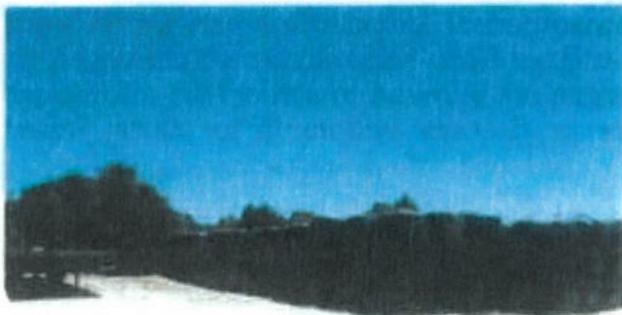
4.2.2 Materials Storage

Potential Pollutants	Sources
Total Suspended Solids (TSS)	Sediment from unpaved driveways and storage areas
Oil and Grease (O&G)	Leaks from trucks, and forklifts

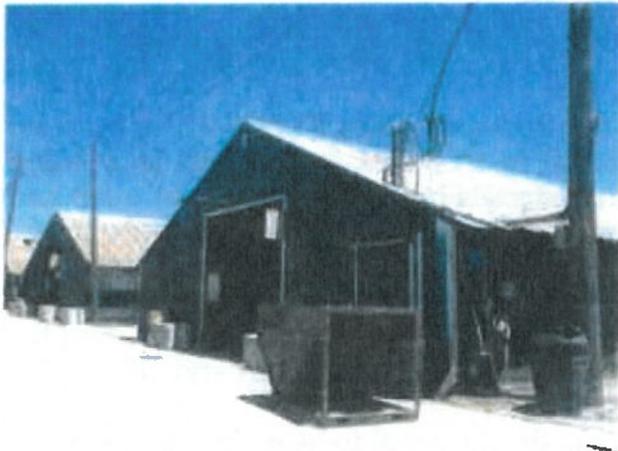
4.3.1 Buildings 1 and 2 - Bagging

Potential Pollutants	Sources
Total Suspended Solids (TSS)	Tracked out debris from bagging operations
Oil and Grease (O&G)	Tracked out leaks from equipment and forklifts

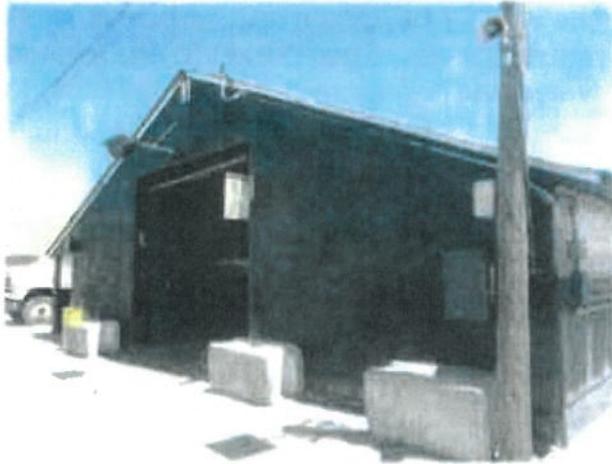
4.3.2 Buildings 3 and 4 – Fertilizer and Coir Storage

Potential Pollutants	Sources
Total Suspended Solids (TSS), Nitrate and Nitrite (N+N), Phosphorous (P)	Tracked out debris from leaks and spills of fertilizer
Oil and Grease (O&G)	Tracked out leaks from trucks and forklifts

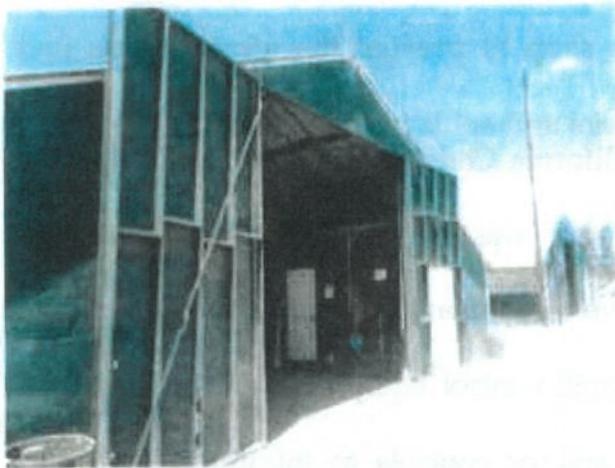
4.3.3 Building 5 – Mechanics Shop

Potential Pollutants	Sources
Oil and Grease (O&G), Zinc (Zn), Iron (Fe)	Tracked out leaks and spills of new and used oil/fluids, residues, and particulates

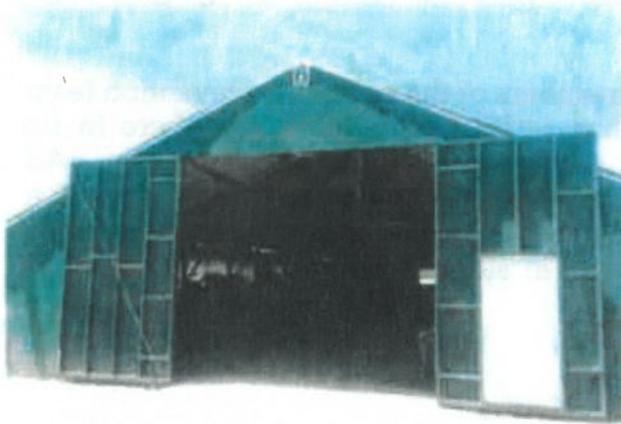
4.3.4 Building 6 – Maintenance Shop

Potential Pollutants	Sources
Oil and Grease (O&G)	Tracked out leaks and spills from equipment

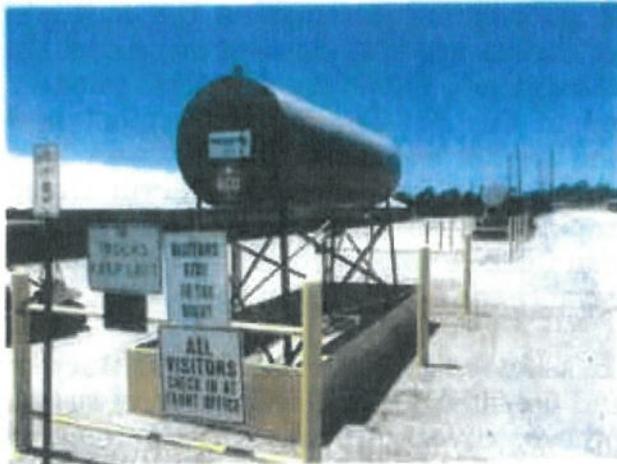
4.3.5 Truck Fueling – Above Ground Storage Tanks

Potential Pollutants	Sources
Total Suspended Solids (TSS)	Sediment from unpaved driveways
Oil and Grease (O&G)	Fuel spills, oil/fluid leaks from truck and loaders

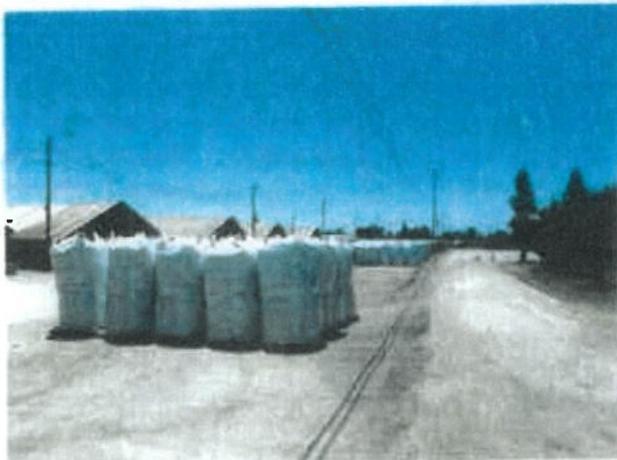
4.3.6 Materials Staging and Peat Moss Storage

Potential Pollutants	Sources
Total Suspended Solids (TSS)	Sediment from unpaved driveways/ aisles
Oil and Grease (O&G)	Oil / fluid leaks from truck and forklifts
