NOTICE OF INTENT TO ADOPT A MITIGATED NEGATIVE DECLARATION

PROJECT: COUNTY ROUNTREE REHABILITATION AND RE-ENTRY FACILITY

PROJECT DESCRIPTION: Proposal to demolish approximately 5,692 square feet of an existing County jail building, to construct additions totaling approximately 14,629 square feet to include a new 7,647 square foot inmate residential wing, new 2,891 square foot visitation building, 2,700 administration addition, 1,391 square foot storage addition, and to remodel approximately 14,256 square feet of existing inmate residential area for a new program training area and 200 square feet of the medium security facility. The project includes grading of approximately 3,800 cubic yards of cut and 4,800 cubic yards of fill, installation of new perimeter security fence, loop road, storm water improvements, outdoor recreation, expanded service yard and inmate intact sally ports, removal of 28 existing trees, planting of 28 replacement trees, and site landscaping. Requires an Amendment to Commercial Development Permit/Coastal Development Permit 90-0603, Soils Report and Arborist Report Review.

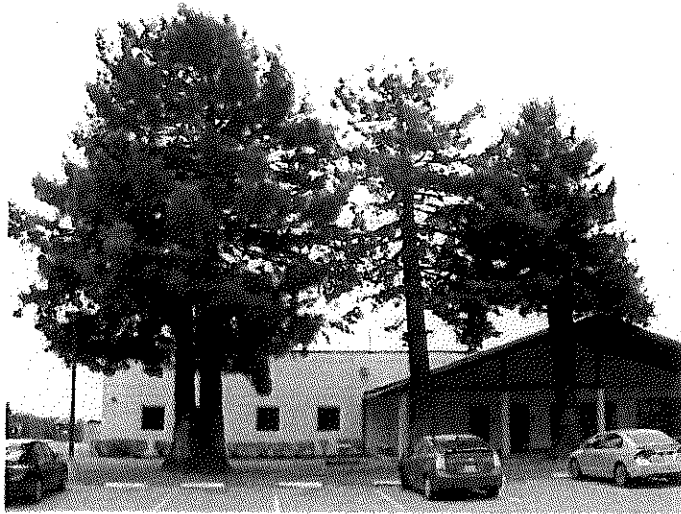
These trees exhibit fair to good condition ratings despite having some symptoms of initial drought stress. Tree #1 has a co-dominant structure (3 similar sized trunks) but appears to be structurally sound. I noted the presence of large exposed roots on the soil surface under the canopies of these trees.

1 - The preliminary grading and drainage plan prepared by Whitson Engineers shows three areas of concern within the proximity of these trees. These issues concern include the following features.

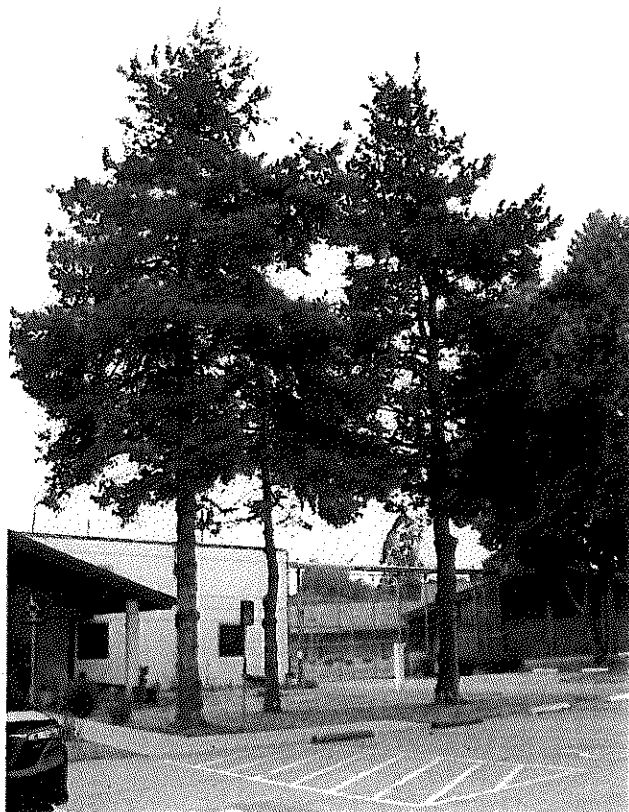
Tree's #4, #5 & #6 – Three Douglas Firs (*Pseudotsuga menziesii*):

These trees have 16 inch, 11 inch and 21 inch DBH measurements, respectively.

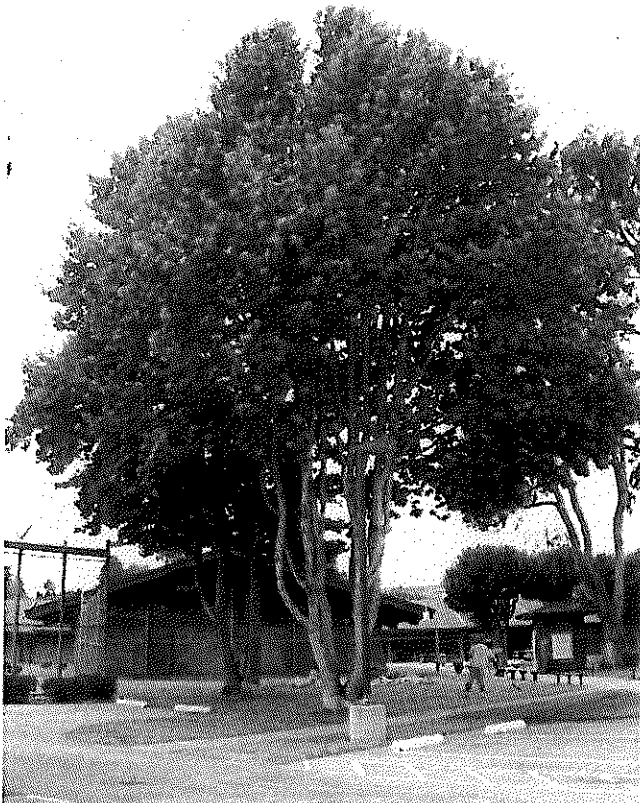
Both of these trees exhibit good health but have very poor structures due to their co-dominant growth patterns. The trees have multiple stems emanating from common trunks near ground level and as such are vulnerable to structural failures.

The footprint of the new administration addition will encroach within the location of Tree #7 and will be setback about three feet away from the trunk of Tree #8.

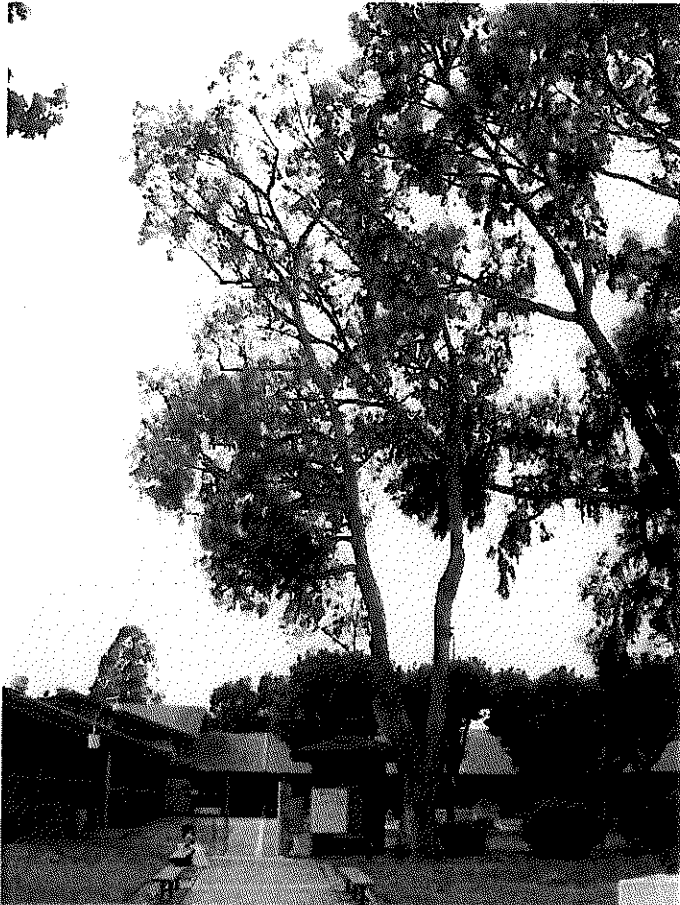
Tree #9 – 33 inch DBH Nichols Eucalyptus (*Eucalyptus nicholii*):

The trunk of this tree will be located about 12 feet inside the location of the new security fence shown on the improvement plans.

The tree exhibits good health and has a fair structure rating.

I recommend that this tree is removed because of its proximity to the inside of the new security fence.

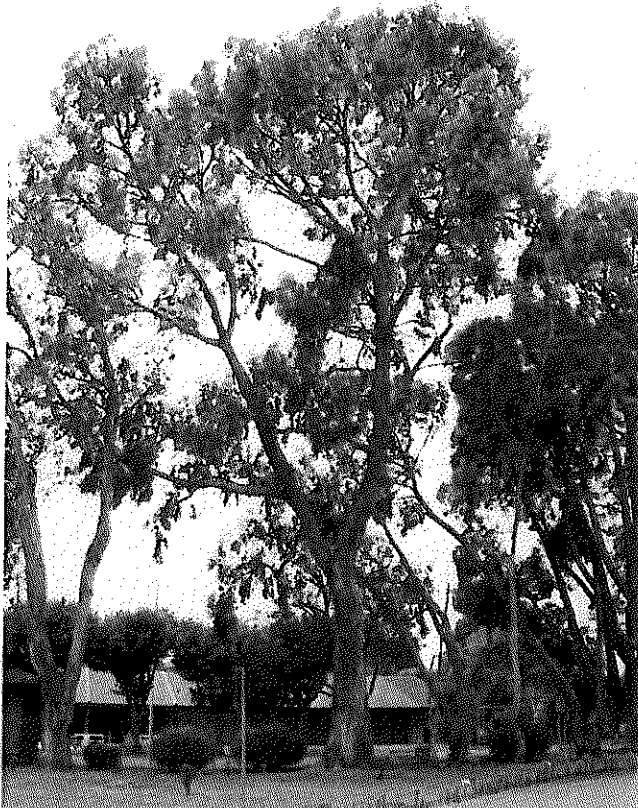
This tree exhibits good health and has a fair structure rating. The base of the trunk of this tree will be situated about two feet outside of the new security fence location. I noted two large buttress roots growing on the soil surface for some distance from the trunk.

I recommend that this tree is removed due to its close proximity to the proposed security fence which will be built on a concrete footing. The footing location will encroach through both of these supportive roots which are too high above existing grade to allow for the utilization of a grade beam on piers as an alternative design to preserve this tree.

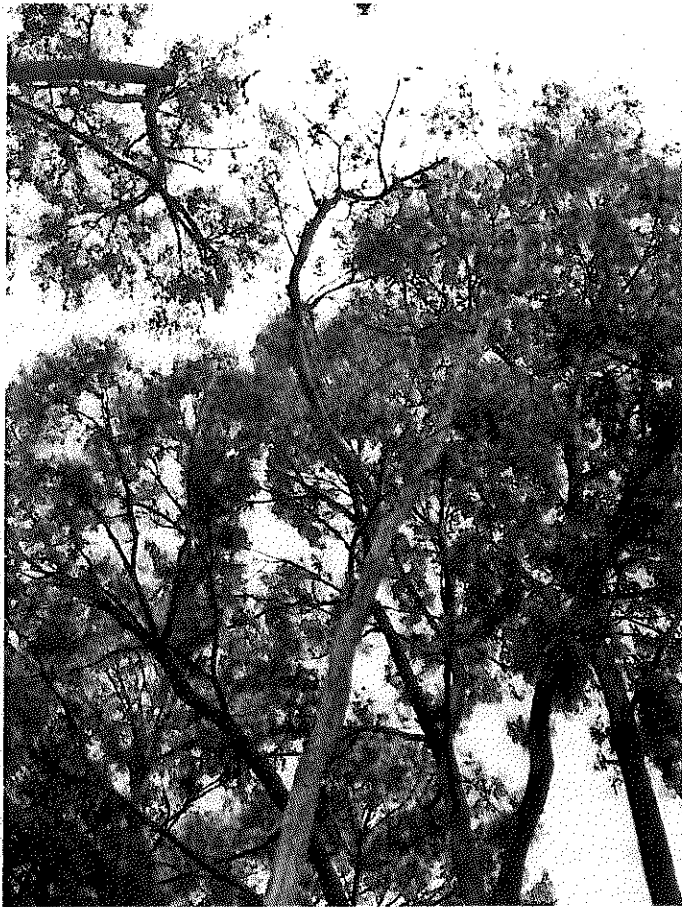
This tree exhibits poor health and has a fair structure rating. The tree is unattractive in appearance and is being suppressed by the larger adjacent trees.

I recommend that this tree is removed because of its poor condition and appearance.

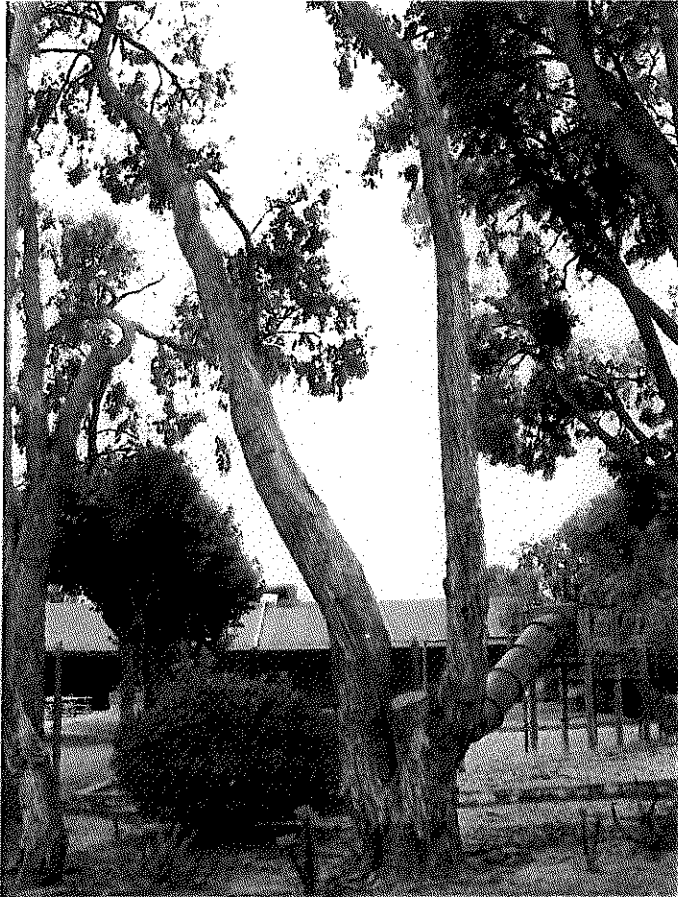
This tree exhibits good health but has a very poor co-dominant structure.

The trunk divides into two co-dominant stems at about three feet above grade. The largest stem leans heavily westward over the proposed landscape area next to the new visitation center. The majority of the limb structure is concentrated at the ends of both stems.

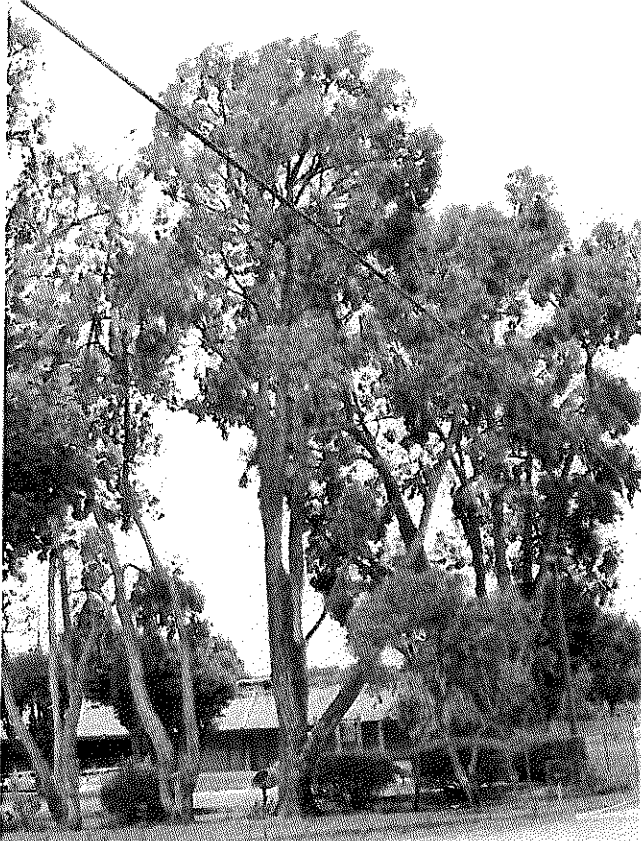
This large tree exhibits good health and has a fair to poor structure rating. I noted that the trunk of this tree divides into two co-dominant stems at approximately nine feet above grade. The area of attachment between these stems is narrow and relatively poor. The north facing scaffold limb (attached at about five feet above grade) is poorly attached to the trunk and appears to be heavy and over-extended. The limb structure within the balance of the upper canopy appears to be relatively light and structurally sound.

I recommend that this tree is preserved and pruned and cabled to improve its structure and safety.

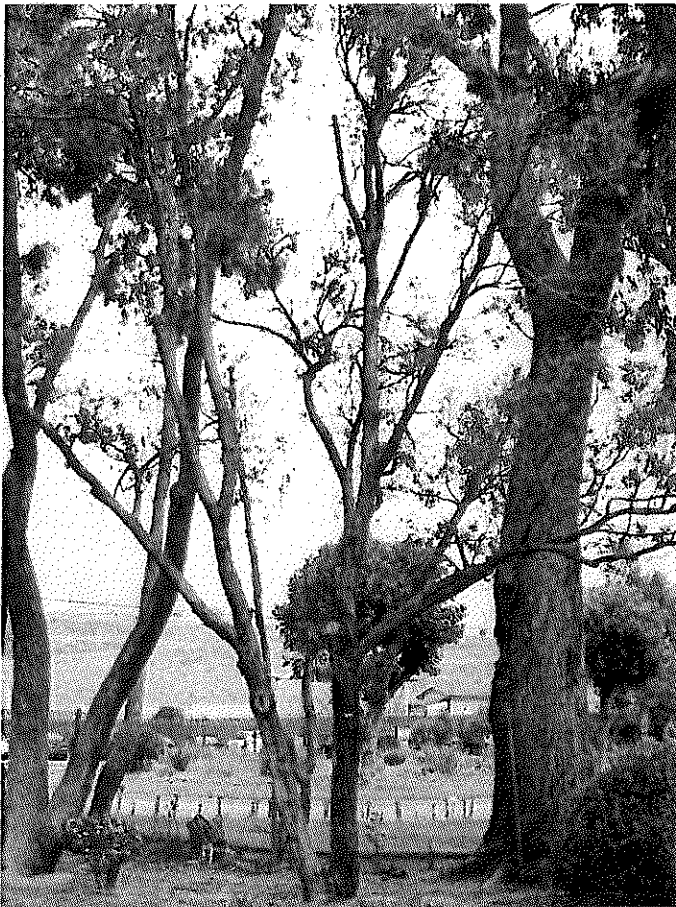
This tree exhibits very poor health and has a poor structure rating.

I recommend that this tree is removed because of its poor condition ratings.

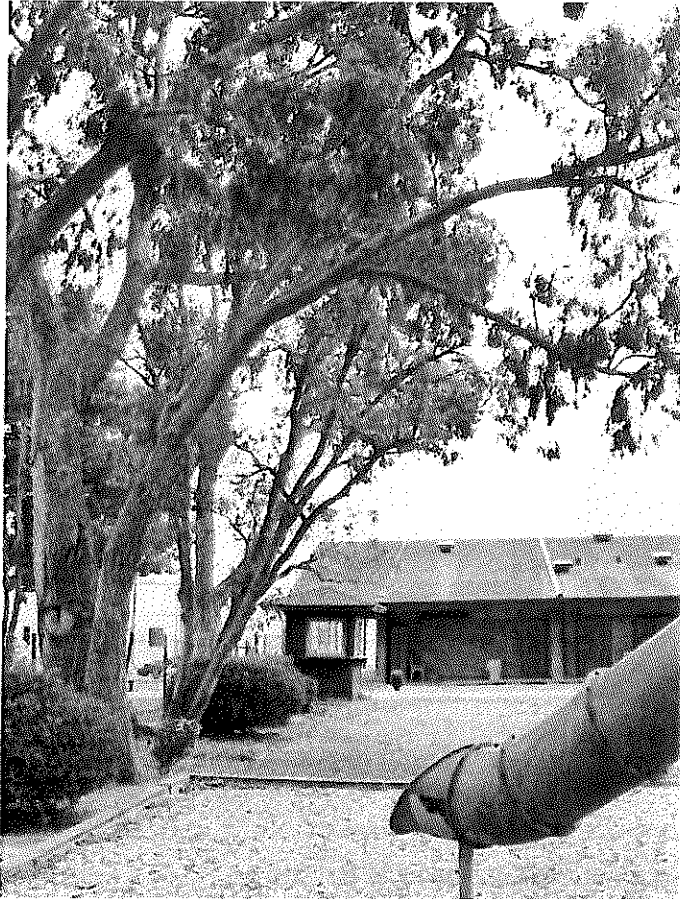
This tree exhibits good health but has a very poor structure rating. The tree leans heavily towards the west and over the proposed visitation building site.

I recommend that this tree is removed because of its very poor structure rating and encroachment over the footprint of the proposed building.

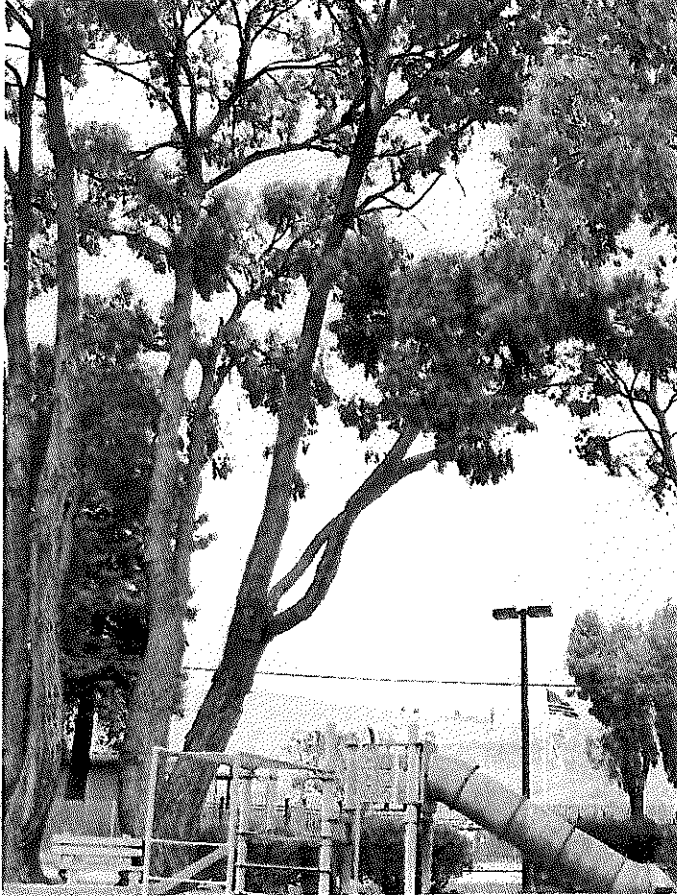
This large specimen exhibits good health and has a fair to poor structure at this time. The tree has a co-dominant structure at about five feet above grade. The south facing co-dominant stem leans heavily to the southeast.

I recommend that this tree is preserved and maintained to improve its structural integrity and safety.

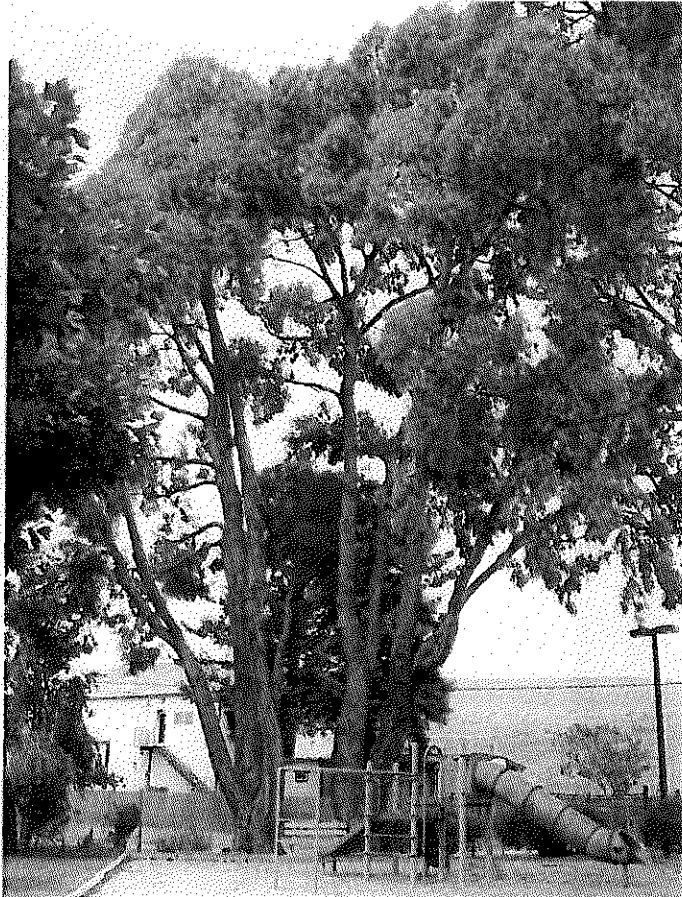
This large tree exhibits good health and a fair to poor structure rating. The tree has four co-dominant stems attached to a common trunk at between four and six feet above grade.

I recommend that this tree is preserved and maintained to improve its structural integrity and safety.

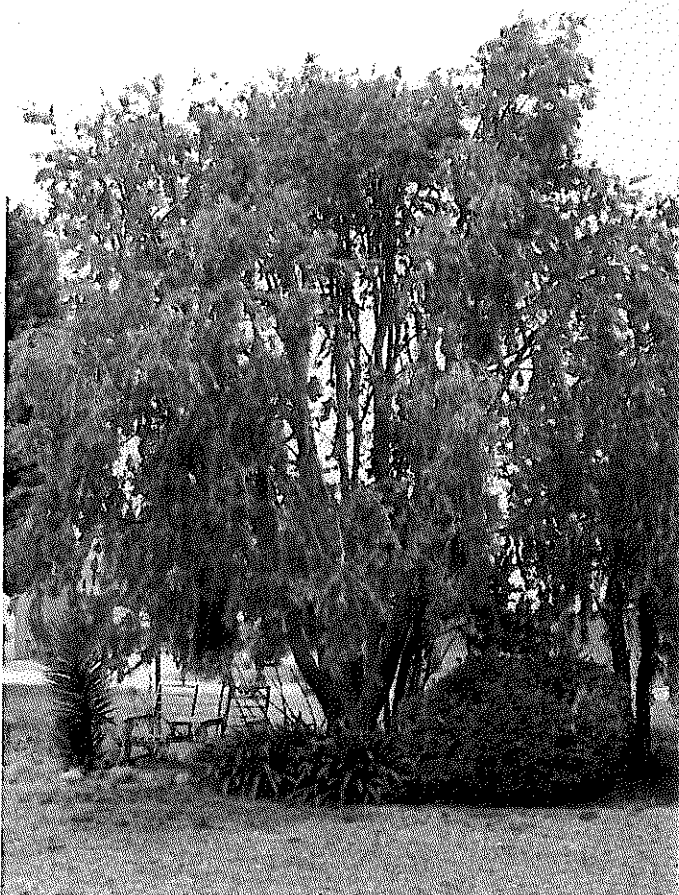
Tree #20 – 6/5/4 inch DBH Bottle Brush:

This tree is the taller of the two Bottle Brush trees. It is in good condition and is an attractive specimen.

I recommend that if at all possible this tree is preserved because it is an attractive tree.

1 – I recommend that the canopy of this tree is raised high enough to provide an acceptable amount of visibility and line of sight regarding security concerns.

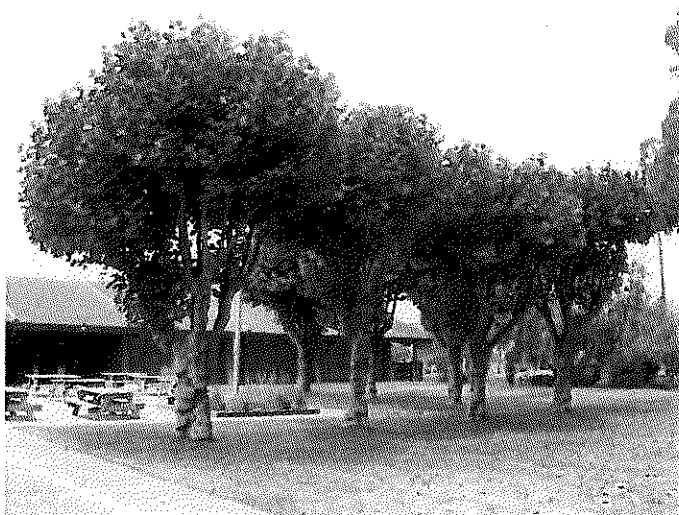
17, 16, 16, 18, 16 & 23 inch DBH, respectively.

These trees are located within the footprint of the proposed visitation center.

Remove all of these trees because of their location within the building footprint.

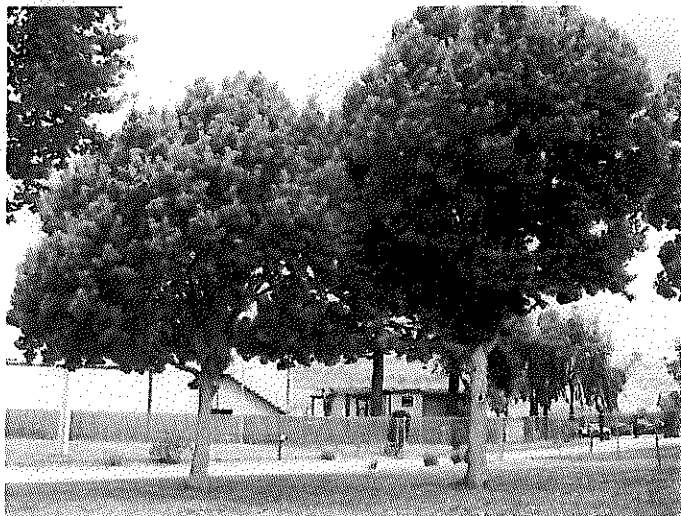
Tree #28 – 16 inch DBH Liquidambar Tree:

This tree has a relatively good condition rating and is located about eight feet inside the proposed security fence location.

Remove this tree because of its proximity to the new security fence location.

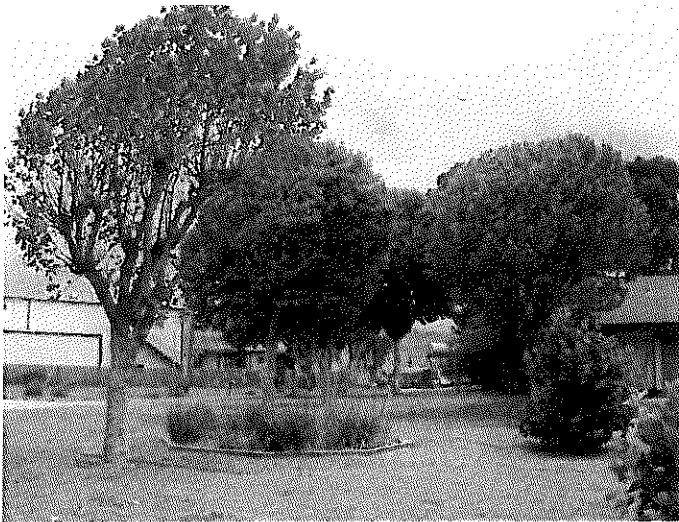
Three of these trees may have to be removed because of their proximity to the new security fence location (Tree's #30 through #32). In the event that they can be retained, they will serve to provide shade and beauty to this area.

I recommend that all of these considerations are evaluated carefully before a final decision is made. The fourth tree (Tree #33) is located near the corner of the building and is set well back from the proposed fence site. This tree could be retained if there are no compelling reasons for it to be removed as it does not appear to be in the way of any improvements.

1 – In the event that any of these trees are to be preserved, install Tree Protection Zone Fencing as shown on the Tree Location Map before any demolition and construction equipment comes on site.

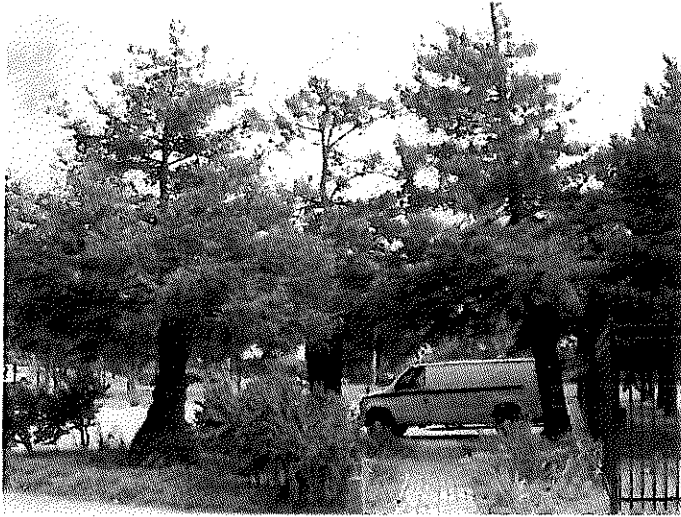
Tree's #44 & #45 – Two Coast Redwood Trees:

These trees have 21 and 32 inch DBH measurements, respectively and are located in the landscaped area that protrudes into the parking area to the north of the service yard. The trees exhibit fair health due to drought stress.

These trees will be encroached upon by the proposed expansion of the asphalt driveway surface and a new pathway.

I recommend the removal of both trees because of their locations within close proximity to proposed infrastructure changes.

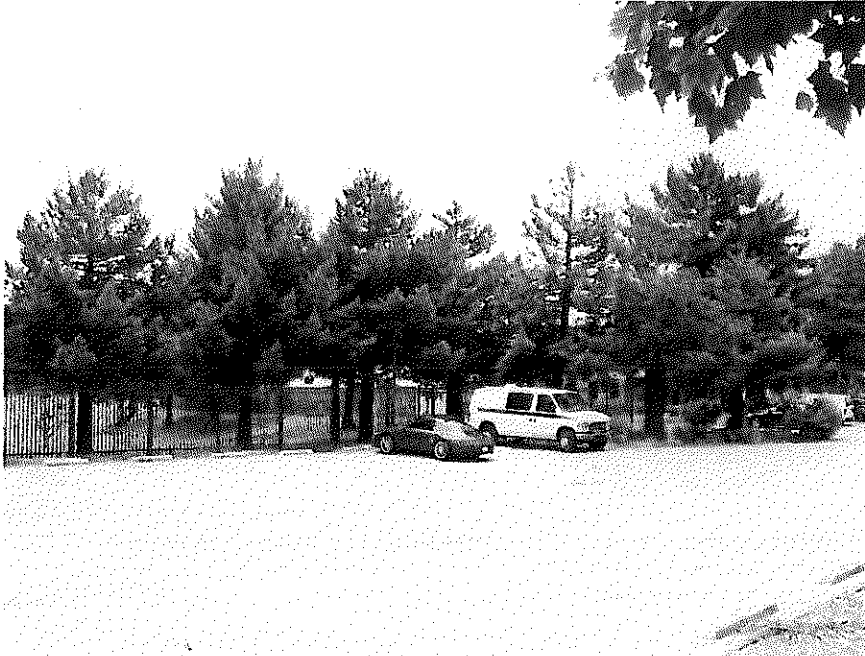
These trees have 13, 20, 19, 19, 17, 18 & 15/8 inch DBH measurements, respectfully.

All of these trees are located within the boundary fence adjoining the eastern parking area. The trees are in fair condition due to the effects of the drought.

I recommend that all of these trees are preserved.

1 - Mulch and irrigate these trees if additional water is available for this purpose (see the notes on irrigation and mulching on page 5).

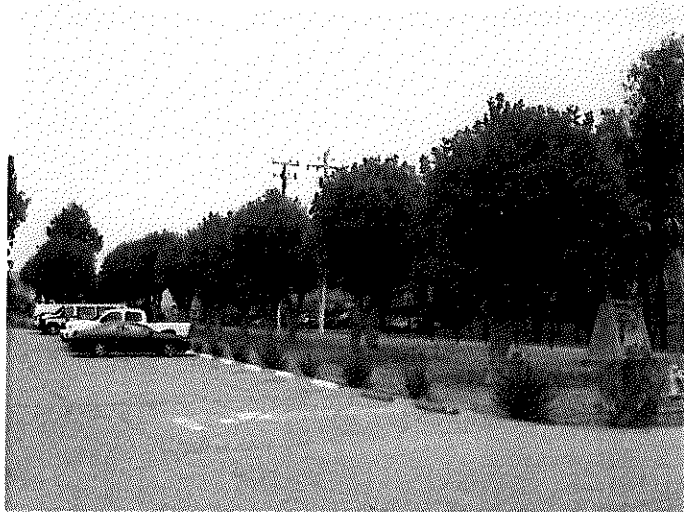
I estimate that the average trunk measurements for these trees approximate 14 inches diameter.

These trees are located in the two areas of turf located next to the frontage of Roundtree Lane and have not been tagged numerically as they are situated well away from proposed construction activity. The trees exhibit good health and have fair to good structure ratings.

I recommend that these trees are protected by two lines of plastic snow fencing installed next to the curbs as shown on the Tree Location Map.

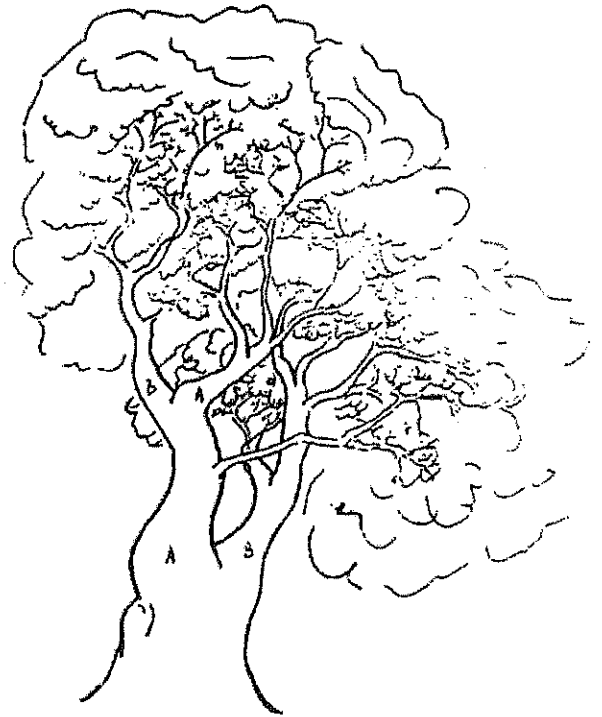
FIGURE 5. A tree with limbs tending to be equal-sized, or codominant. Limbs marked B are greater than $\frac{3}{4}$ the size of the parent limb A. Thin the foliage of branch B more than branch A to slow its growth and develop a stronger branch attachment.
