Phase I Environmental Site Assessment Report

Jaye's Timberlane Resort
8705 Highway 9
Ben Lomond, CA 95005

Prepared by
Remediation Risk Management
2560 Soquel Avenue
Santa Cruz, CA 95062

December 28, 2021
Project # IMK798

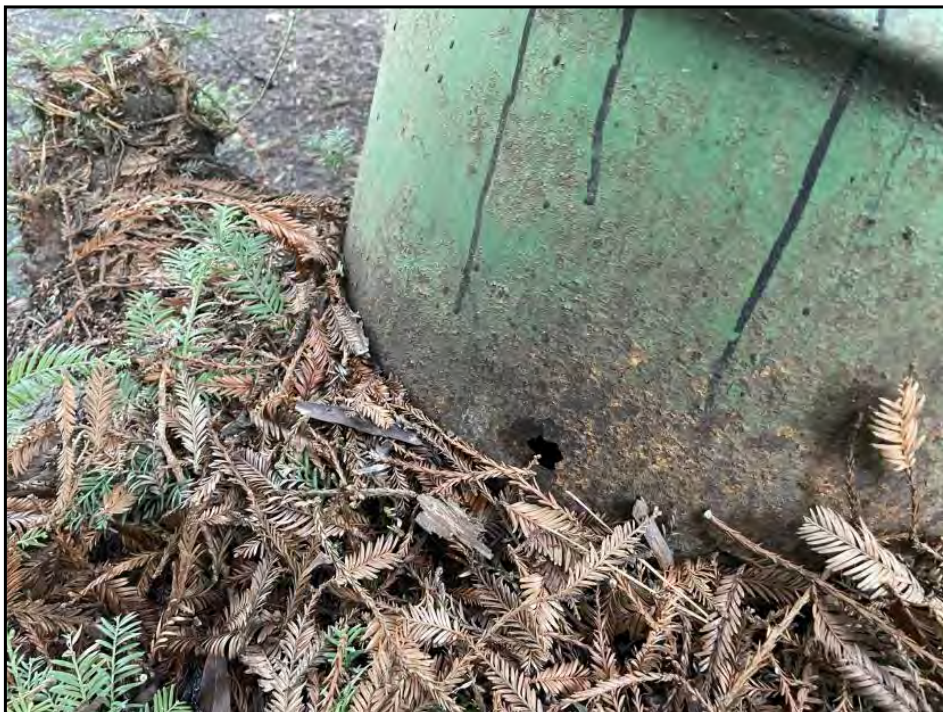
Two 55-gallon drums were observed on the Property. The drums were reported by the current Property owners as containers formerly used for the storage of asphalt sealant. The drums were reported by the owners to be empty.

Two unidentified substance containers were observed on the Property during the inspection. These containers were later identified by the Property owner as formerly used for asphalt sealant (also reported in Section 6.3.7).

8 : Hole in bottom of drum formerly used for asphalt sealant.

Remediation Risk Management recommends removing empty drums, containers, and any other waste materials currently stored at the Property.

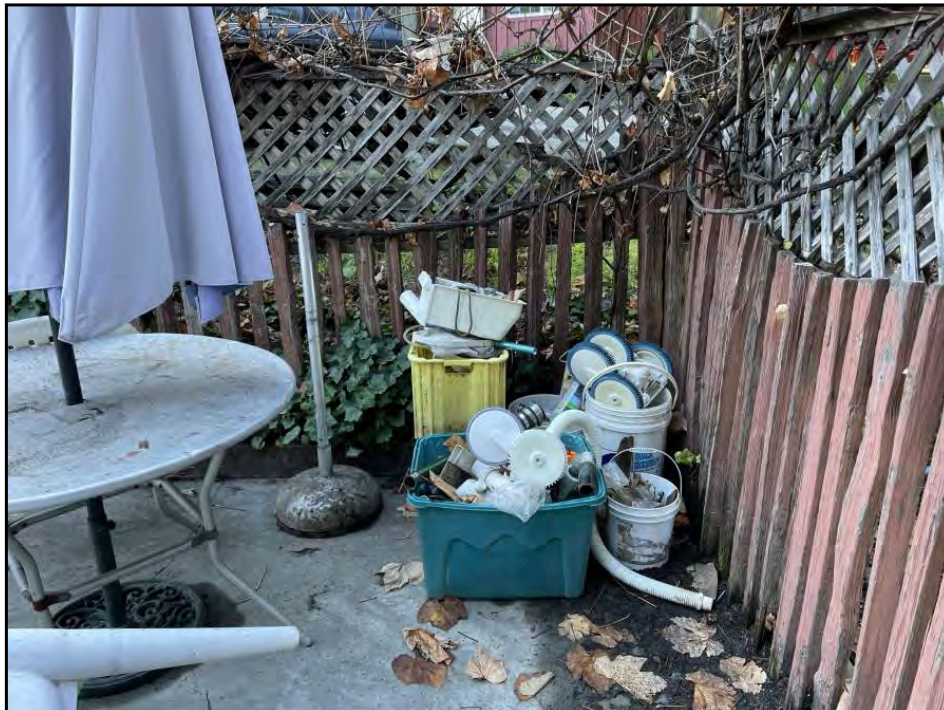
Chlorine and other swimming pool chemicals were observed on the Property in connection with pool maintenance. The Property is supplied with propane cooking and heating fuel stored in an onsite pressure tank. No other hazardous substances were observed on the Property during the Property inspection.

26 : Chemicals and equipment associated with swimming pool.

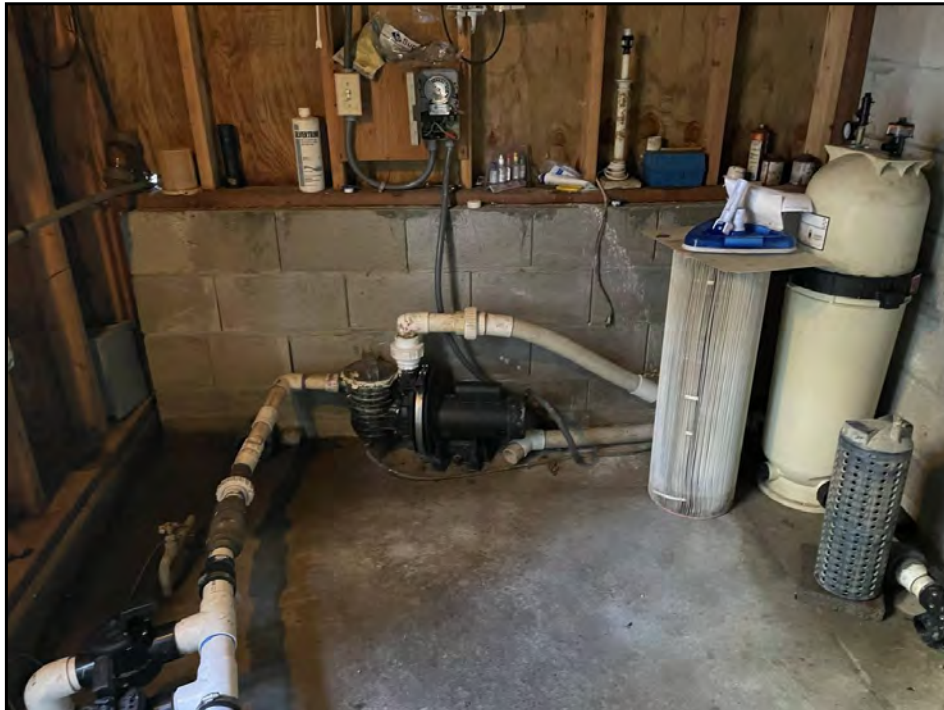
27 : Interior of pool structure.

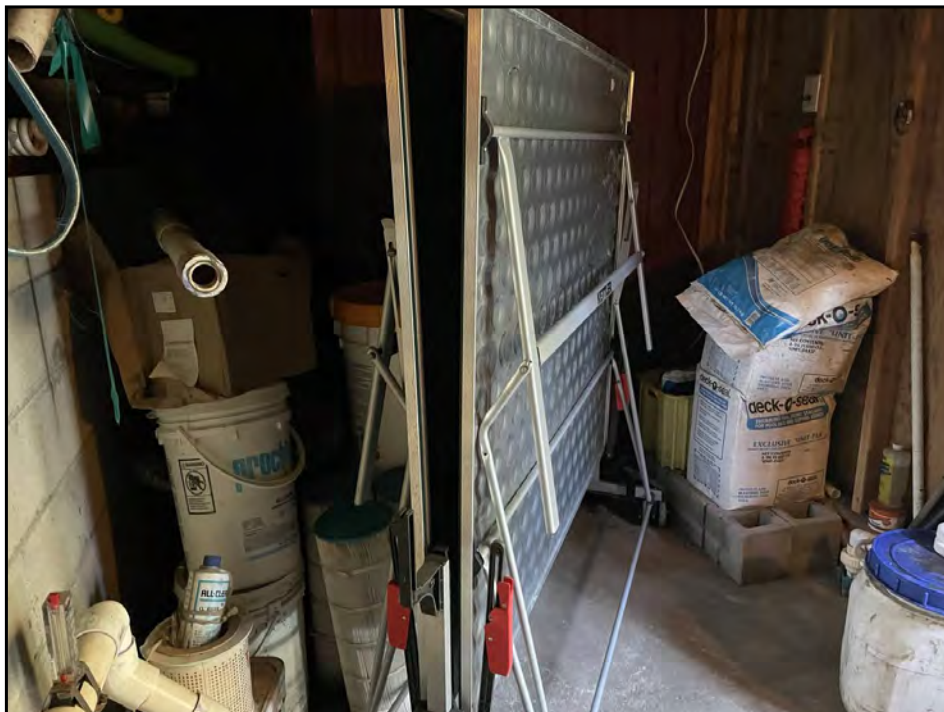
28 : Pool chemicals stored in structure adjacent to pool.

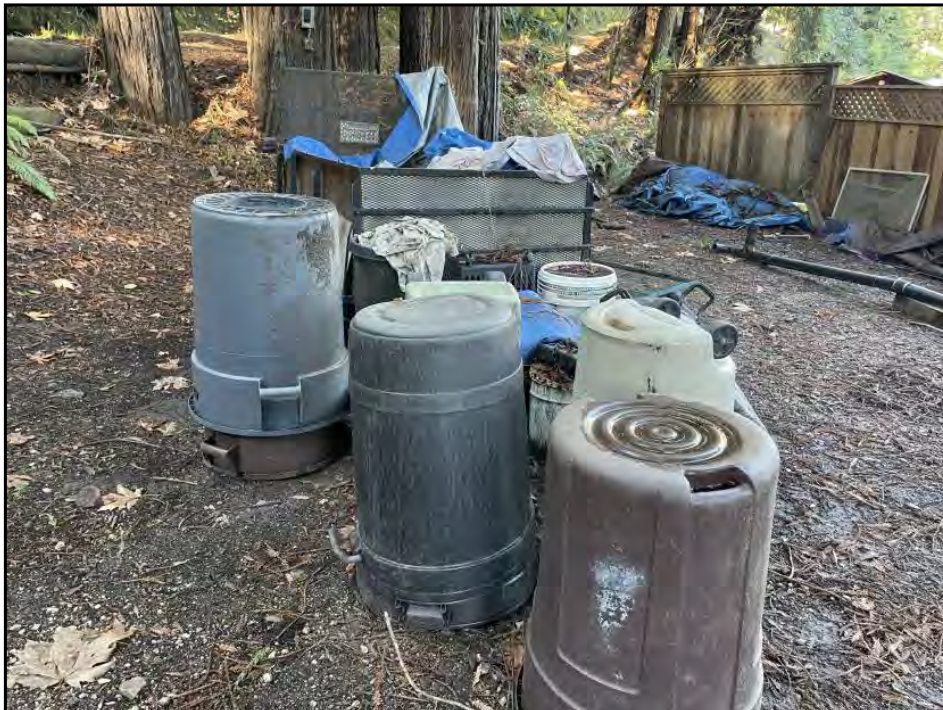
30 : Empty trash containers.

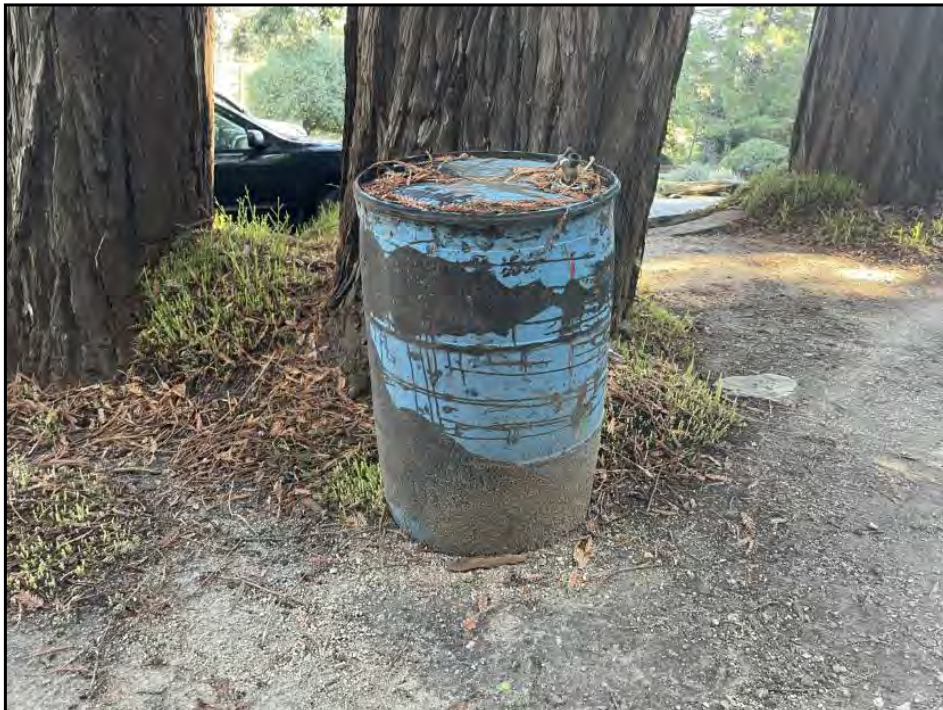
32 : Drum formerly used for storage of asphalt sealant.

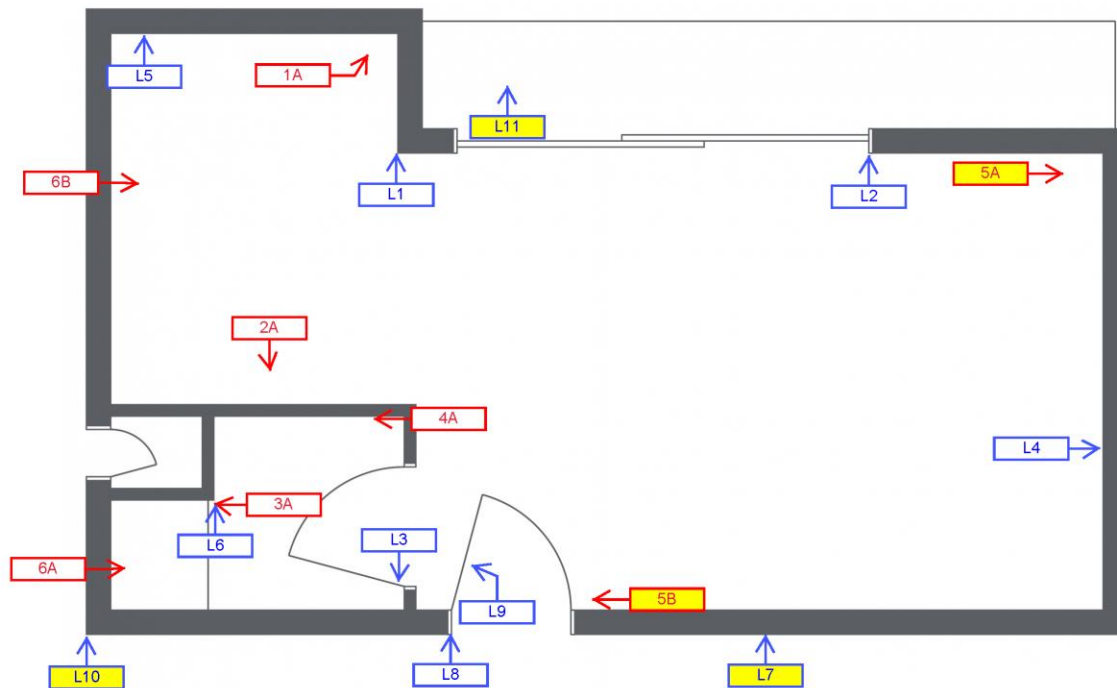
Client: Santa Cruz County Veterans
 Project Name: HazMat Inspection
 Location: 8705 Highway 9, Ben Lomond
 Building: Cabin 9
