Chapter 5: Large Woody Debris

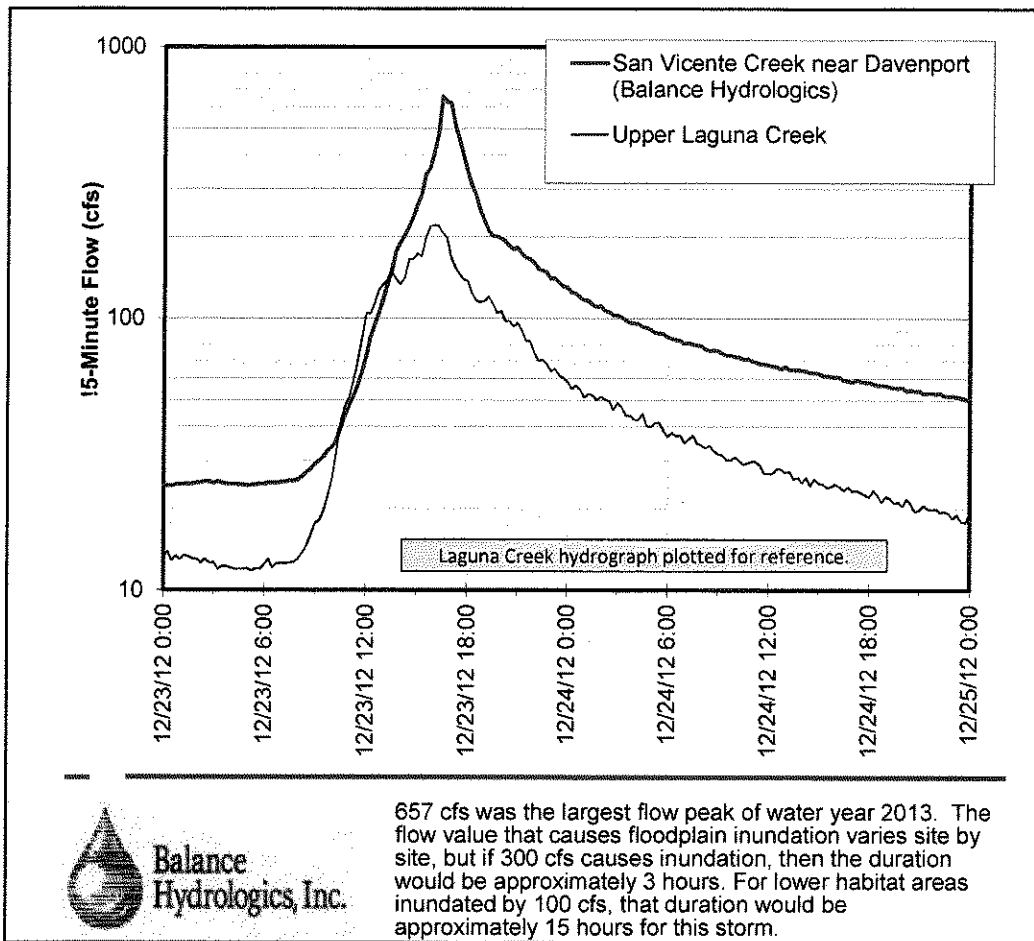
Figure 3-9. Peak flow hydrograph: San Vicente Creek, water year 2013

However because San Vicente is a small and steep watershed, flood durations last only for short periods, so many complex habitat features may best be viewed as short-term high-flow refuge unless they are well connected to the creek at low flow.

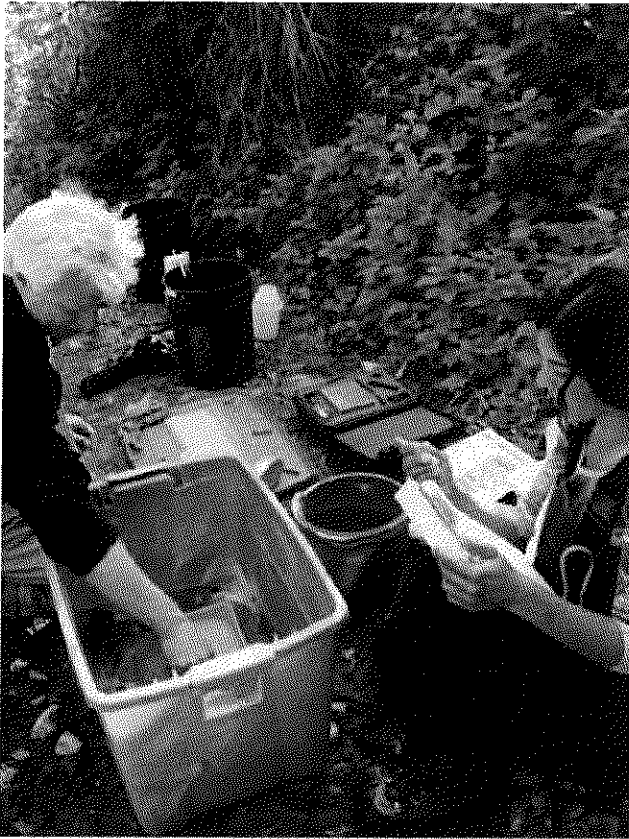
Figure 4-2. Processing of juvenile salmonids captured in San Vicente Creek, Spring 2013

Marked fish were released approximately 200 feet upstream of the outmigrant trap. PIT tag codes were used to identify and quantify marked and subsequently recaptured fish.

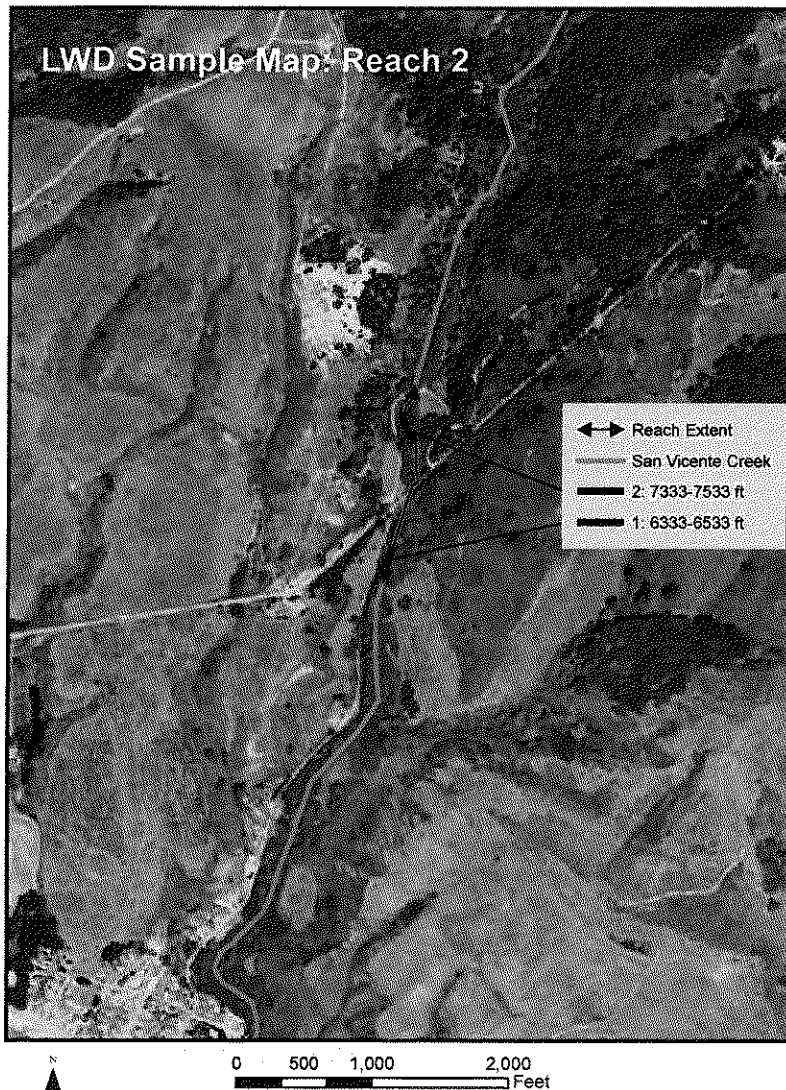
Figure 5-1b. Reach 2 LWD sample map.

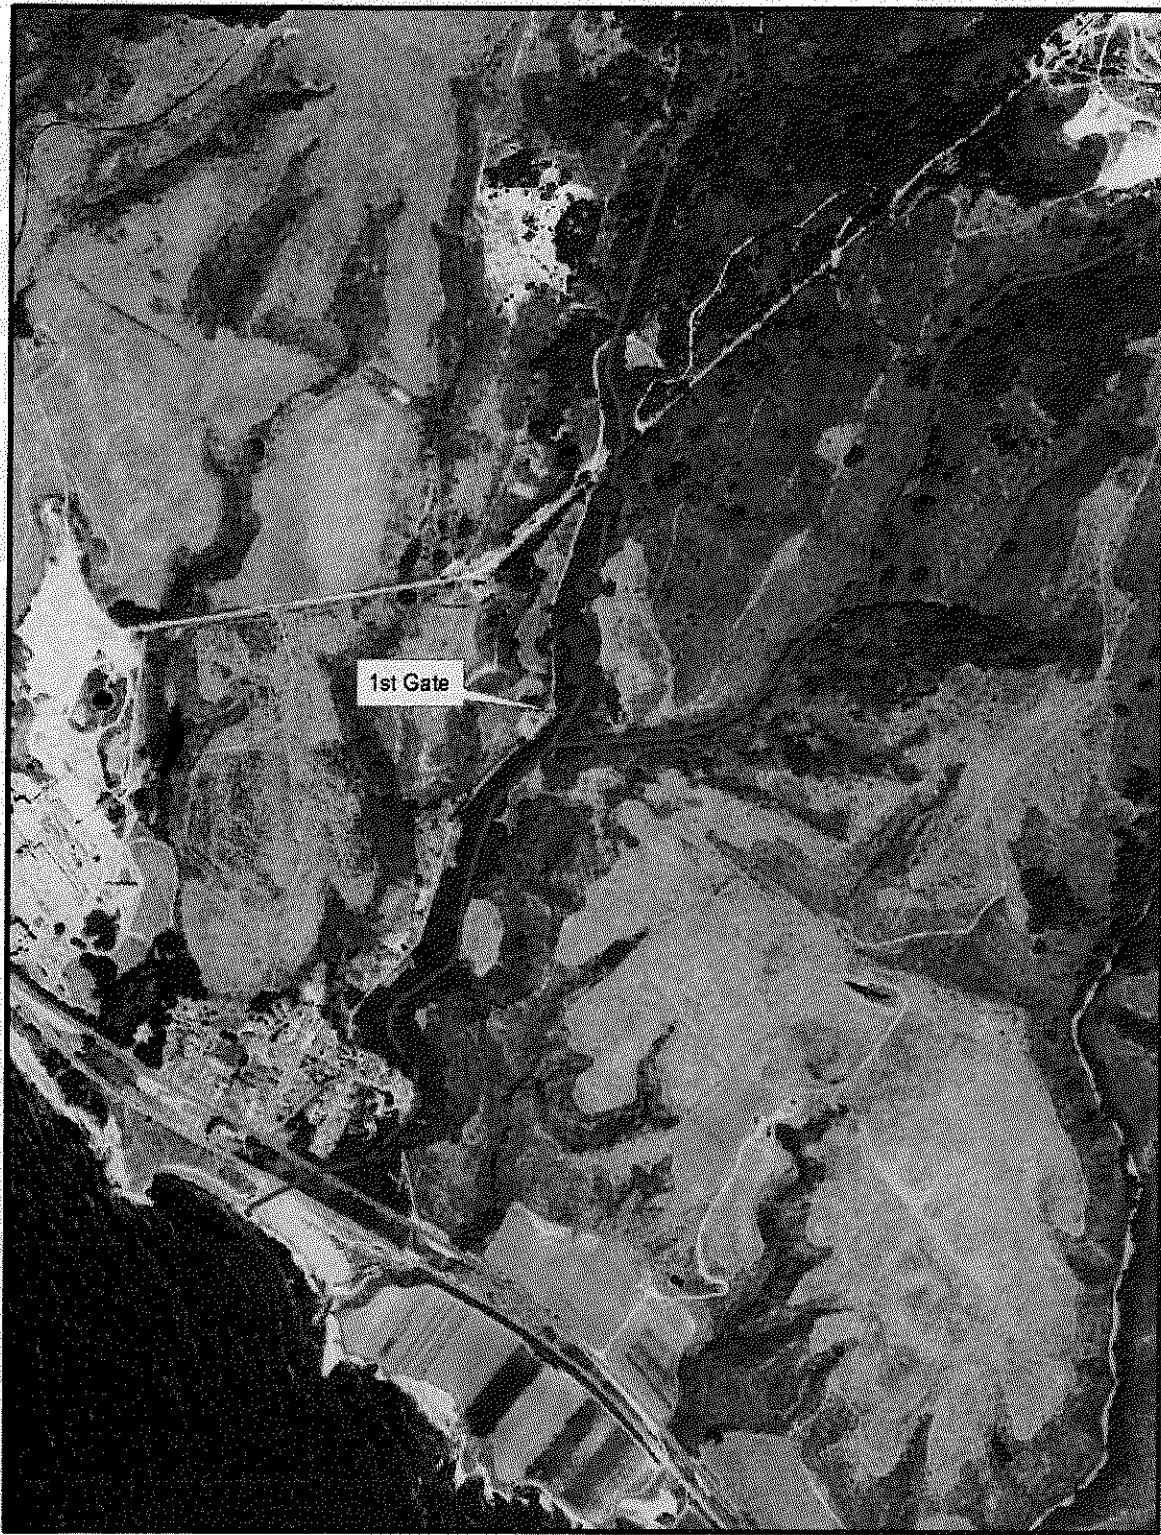
Figure 6-4 4. Cape Ivy Area Map

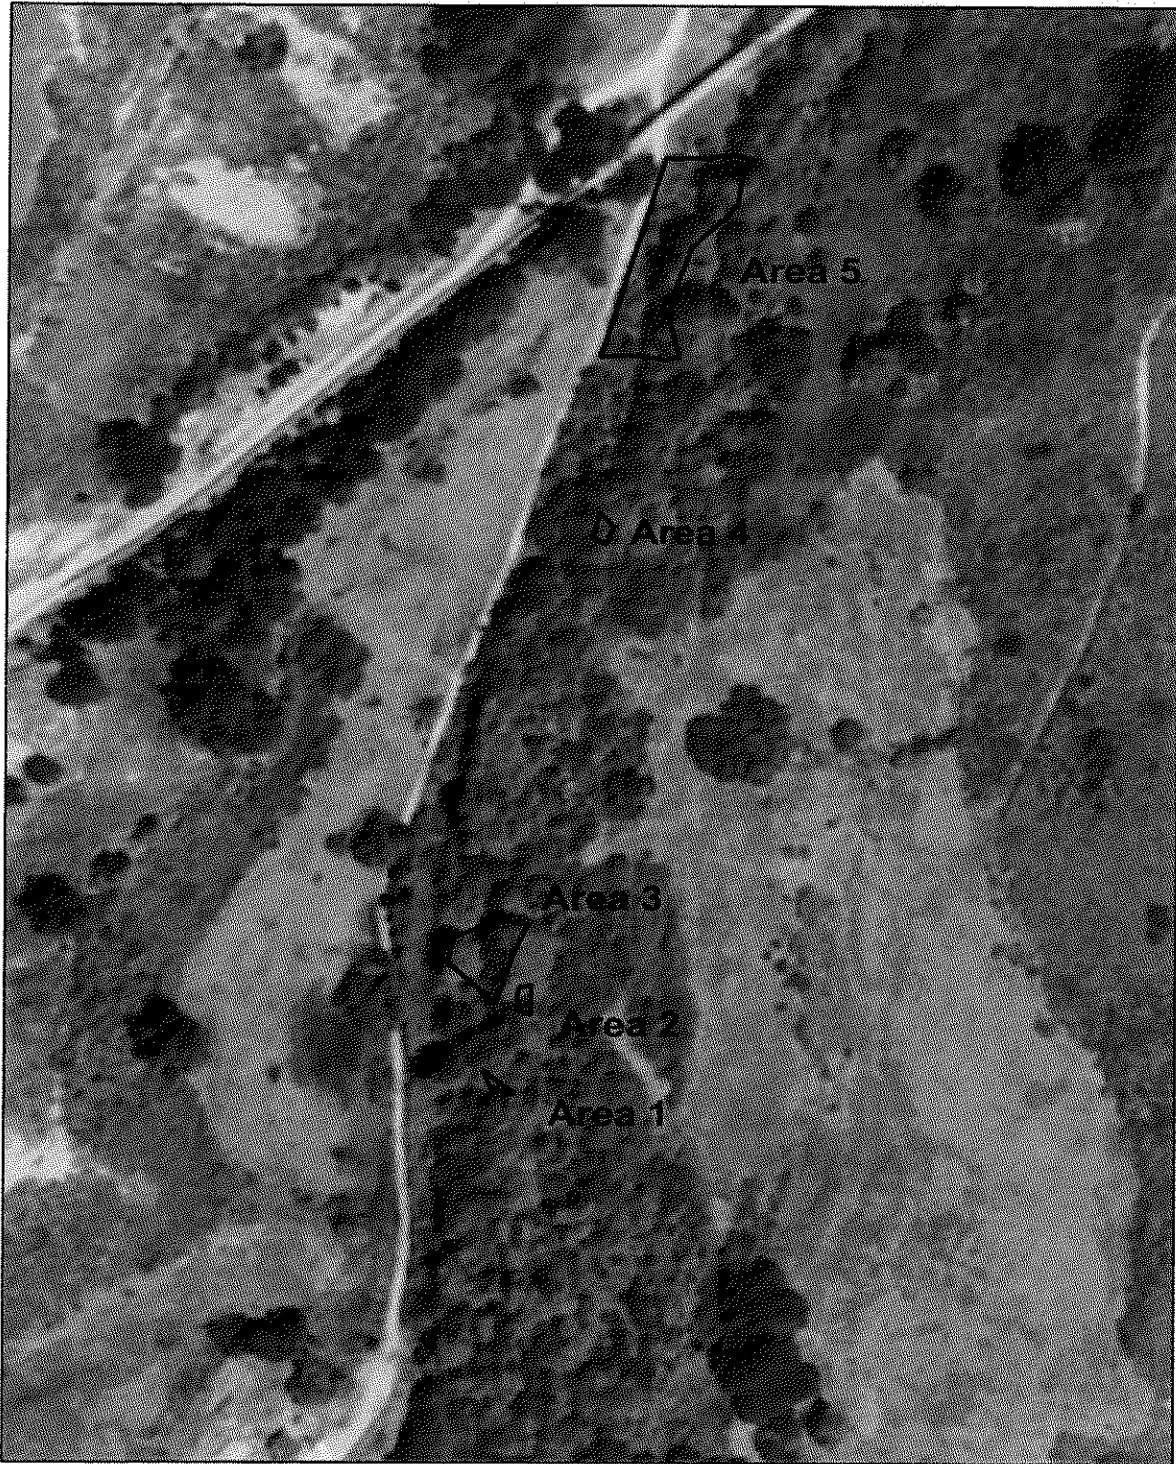
Figure 6-5. Cape ivy patch map

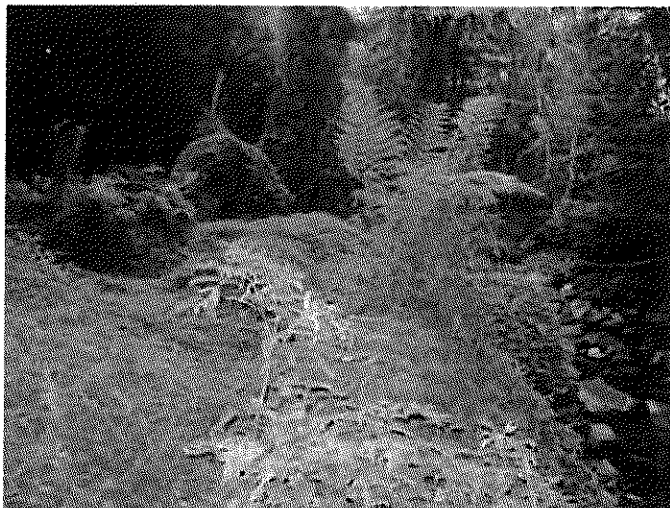
Figure 6-6. Clematis blankets the ground in the upper reaches of San Vicente Creek.

While Reach 3 is devoid of Cape ivy, the riparian habitat is dominated by Clematis, particularly in areas where the canopy is less dense and more sunlight is available. In the upper extent of this reach, Clematis blankets the ground (>70%) and is present in California Redwood (*Sequoia sempervirens*) and Alder trees up to heights of 30 feet. Clematis forms a solid wall in some areas and native herbaceous plants are limited in these areas (see Figure 6-6).

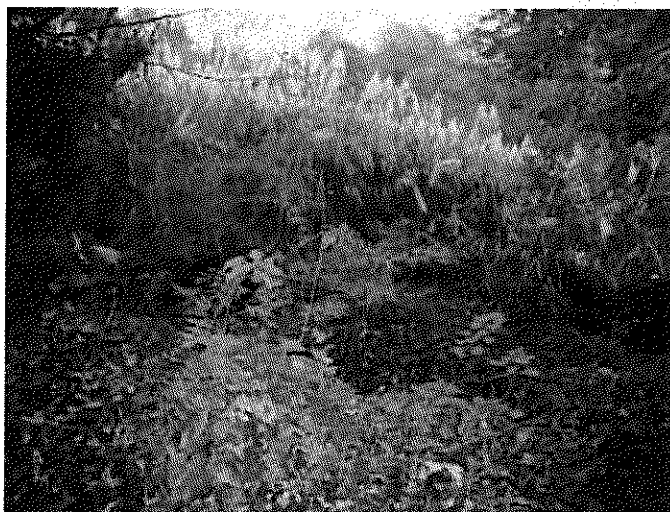
Figure 6-7. Two large patches of jubata grass are near the tunnel on San Vicente Creek.

Two large patches of jubata grass exist on the right bank (facing upstream) in the upper extent of Reach 3, near the tunnel on San Vicente Creek. They are fairly close together and appear to have colonized on old landslides/scarps (see Figure 6-7).

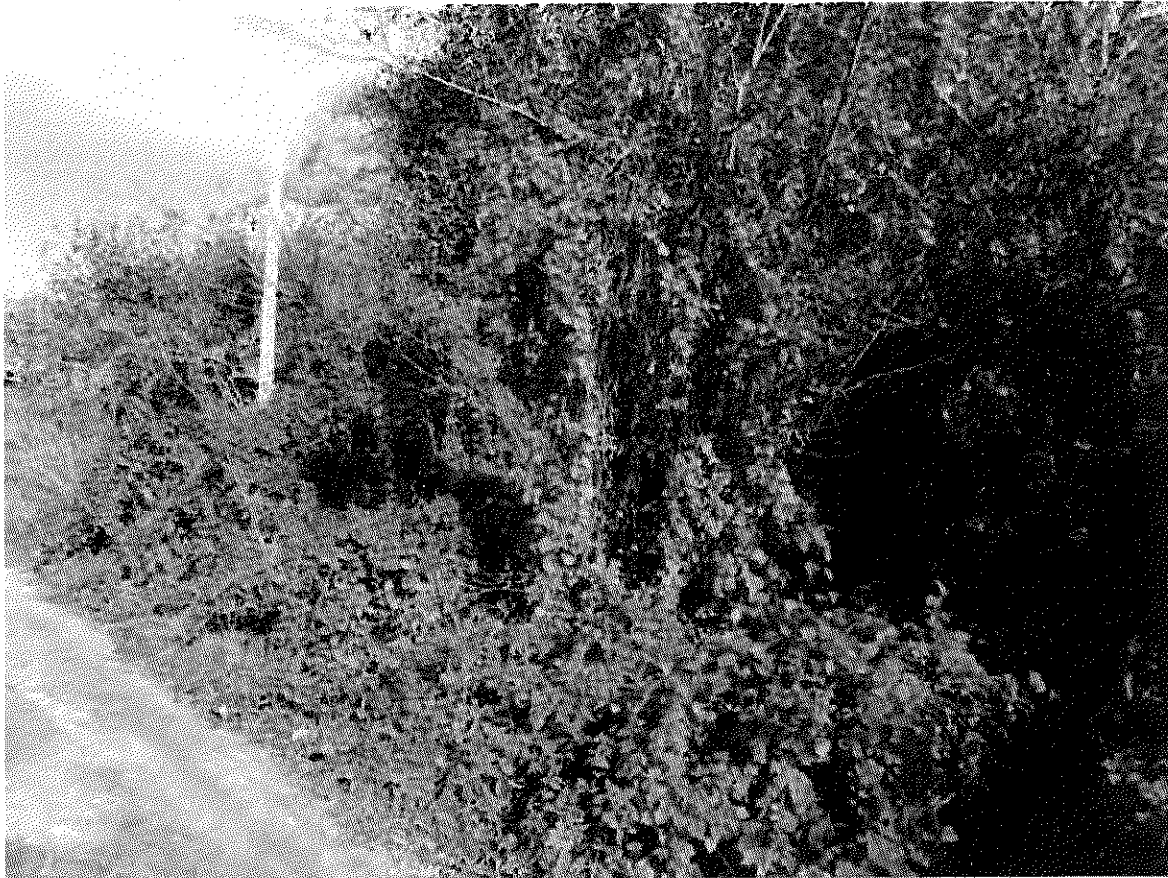
The following photographs document the cape ivy as seen along the road:
