AQUATIC RESOURCE DELINEATION REPORT

LAKEVIEW ESTATES (APN 051-411-20)
WATSONVILLE, SANTA CRUZ COUNTY, CALIFORNIA

MAY 2018

Tom Mahony, MS, PWS
Certified Professional Wetland Scientist #2567
Coast Range Biological LLC
PO Box 1238
Santa Cruz, CA 95061
(831) 426-6226
coastrange@sbcglobal.net

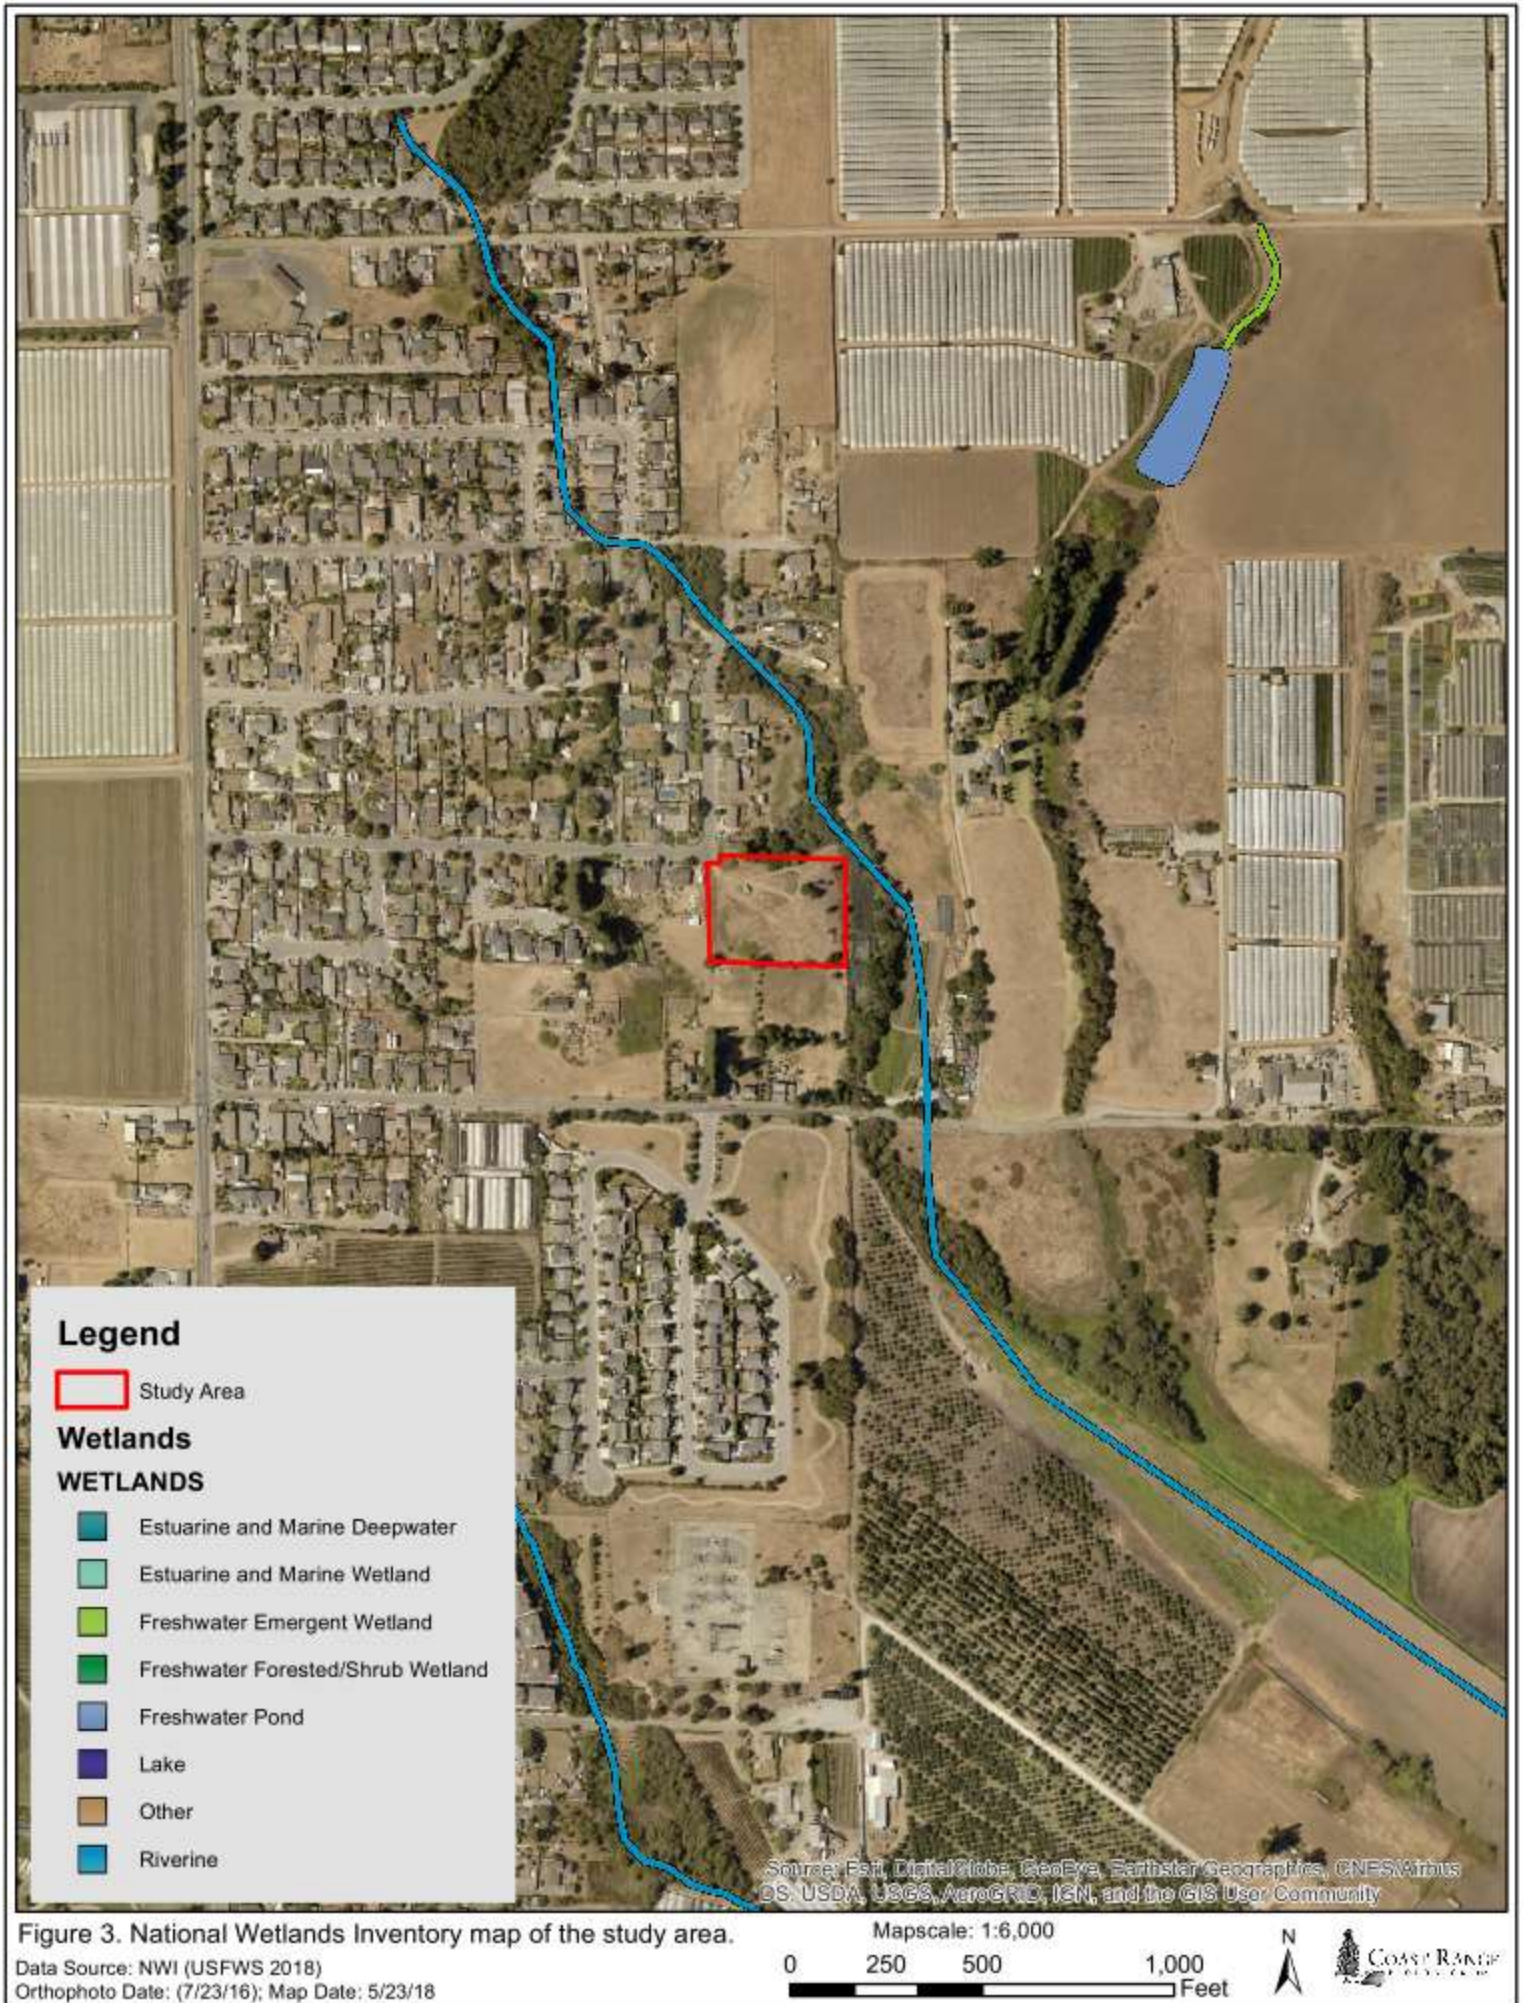
Figure 3. National Wetlands Inventory map of the study area.

Data Source: NWI (USFWS 2018)
 Orthophoto Date: (7/23/16); Map Date: 5/23/18

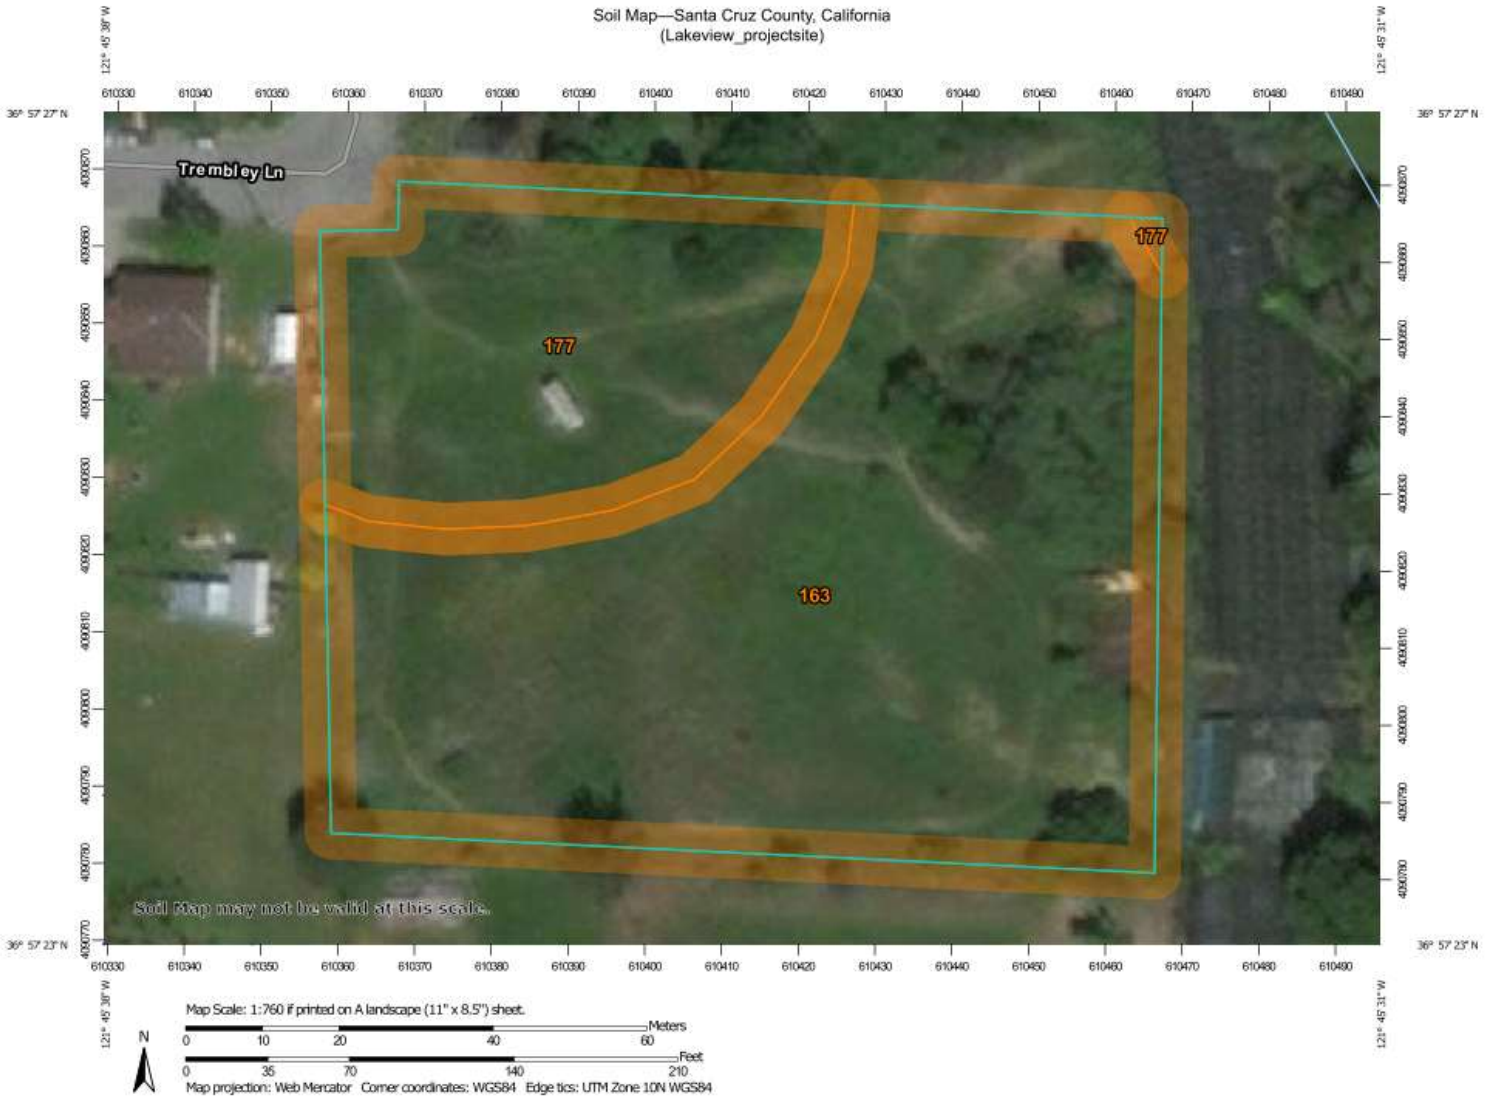
Soil Map—Santa Cruz County, California
(Lakeview_projectsite)

Map Unit Symbol	Map Unit Name	Acres in AOI	Percent of AOI
163	Pinto loam, 9 to 15 percent slopes	1.6	72.5%
177	Watsonville loam, 2 to 15 percent slopes	0.6	27.5%
Totals for Area of Interest		2.3	100.0%

Both of these soils can be considered hydric soils for Santa Cruz County when found on marine terraces (NRCS 2018b). A soil map of the study area is included in Appendix B.

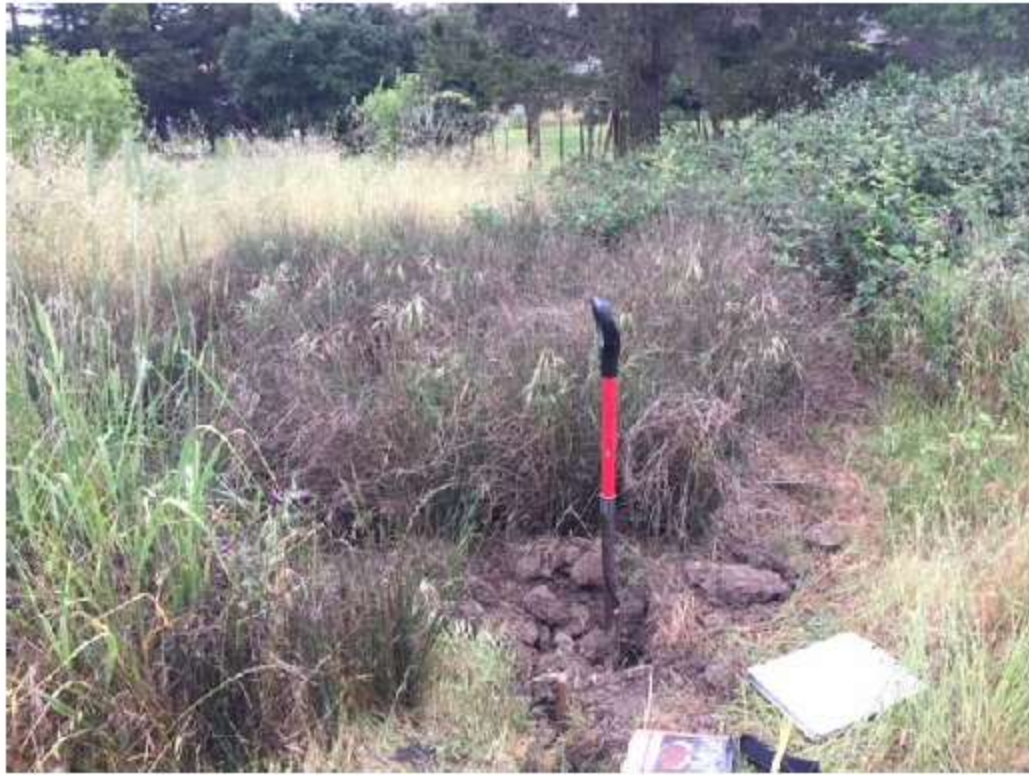
Appendix C-1. Wetland 1 dominated by spreading rush at Sample Point 1a.

Wetland 1 covers 2,774 ft² (0.06-acre) and occurs in the southwestern portion of the study area on sloped terrain that appears to receive surface and near-surface runoff from upslope (Table 2; Figure 4; Appendix C-1, C-3). Wetland 1 is dominated by hydrophytic vegetation, including spreading rush and Himalayan blackberry (Sample Points 1a, 2a). Hydric soil indicators are present throughout Wetland 1, such as Redox Dark Surface (F6), as well as wetland hydrology indicators, including Sediment Deposits (B2), Surface Soil Cracks (B6), Drainage Patterns (B10), and Shallow Aquitard (D5). The shallow aquitard (heavy clay layer) observed in this area may be perching water and contributing to wetland hydrology. Adjacent uplands occur on slopes above the wetland, and are dominated by upland species such as wild oats, riggut brome, and hairy vetch (Appendix C-2). These uplands lack wetland hydrology and hydric soil indicators (Sample Point 2b), or contain some hydric soil indicators, presumably due to the aforementioned shallow aquitard that perches water near the surface, but of insufficient duration to produce wetland hydrology (Sample Point 1b).

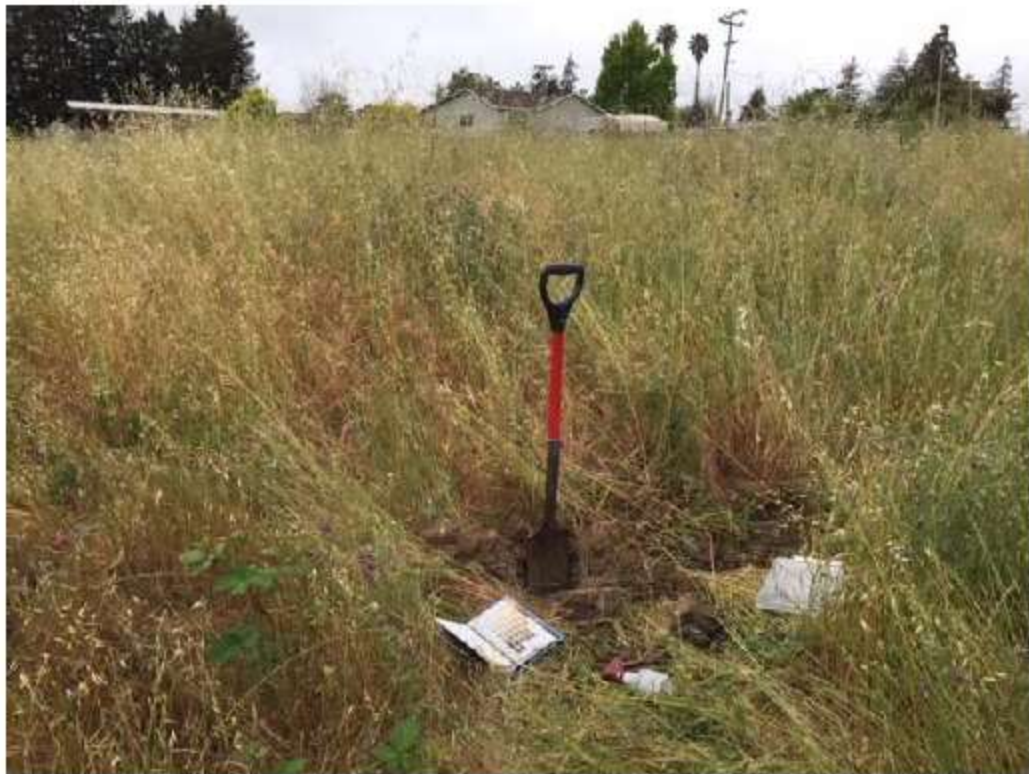
Appendix C-2. Non-Native Grassland dominated by slender wild oat and other upland species at Sample Point 1b.

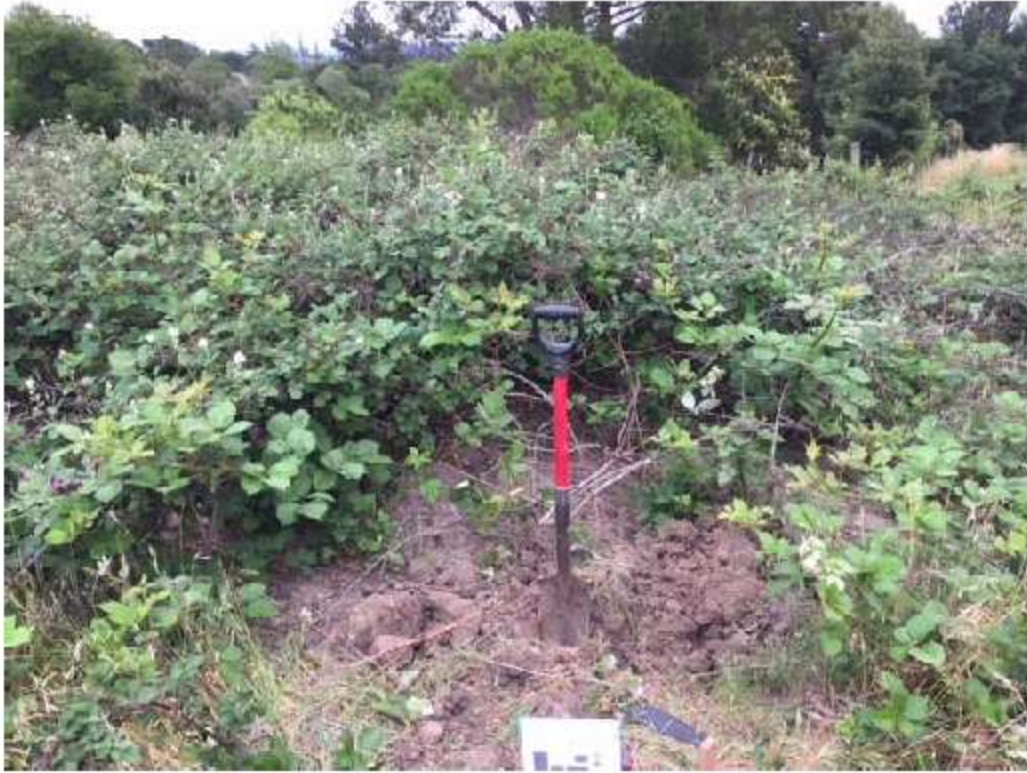
Appendix C-3. Wetland 1 dominated by Himalayan blackberry at Sample Point 2a.

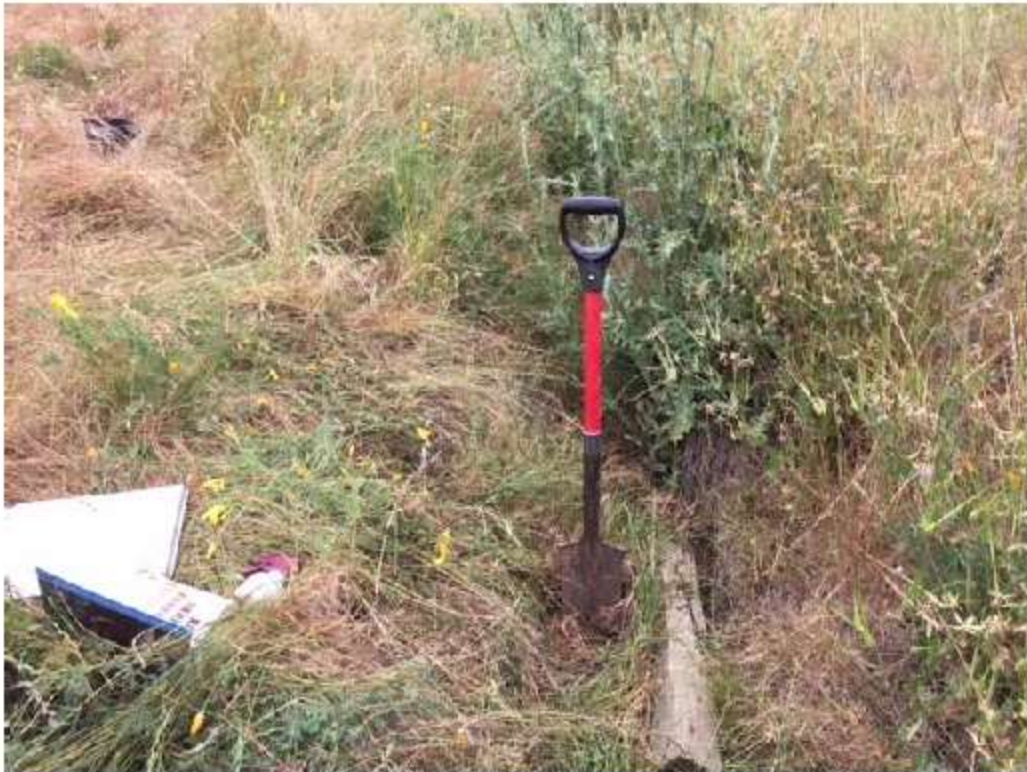
Appendix C-4. Man-made drainage ditch lacking an OHWM and positive indicators of all three wetland parameters at Sample Point 3.

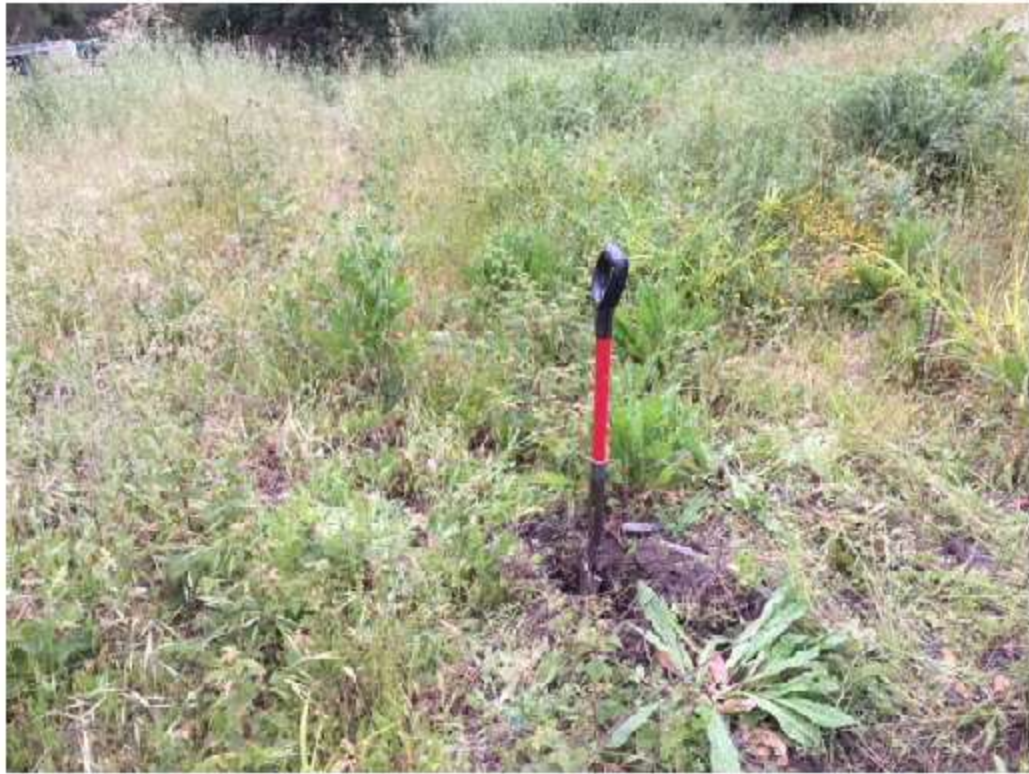
Appendix C-5. Wetland 2 in shallow swale at Sample Point 5a.

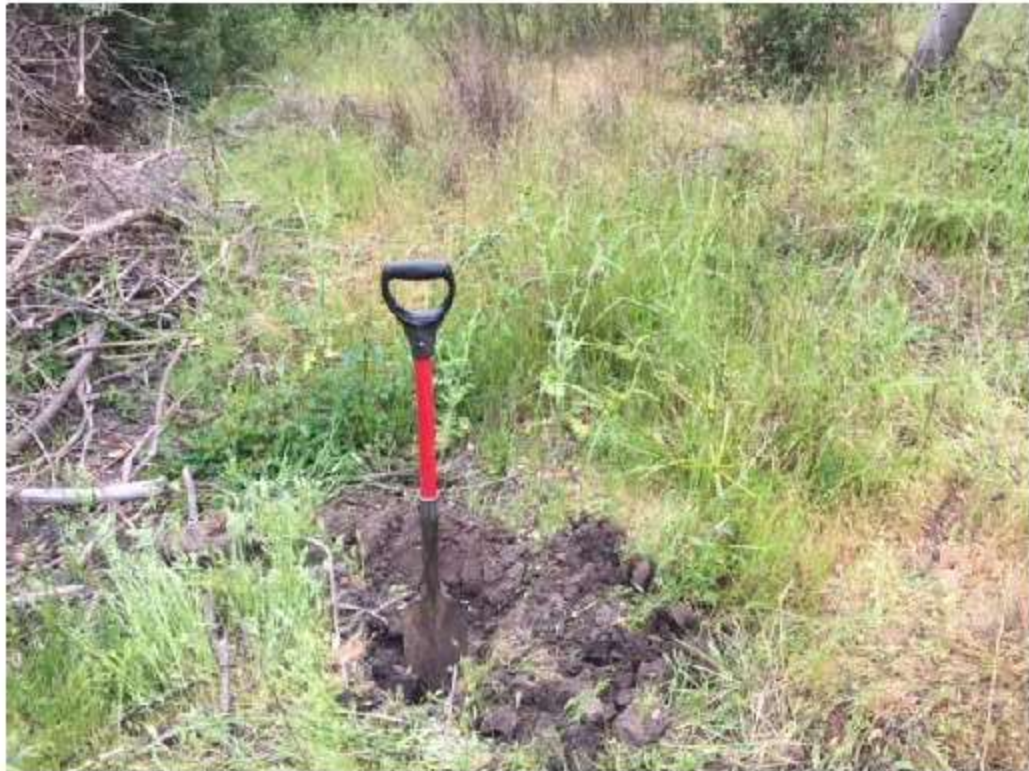
Appendix C-6. Wetland 2 in shallow swale at Sample Point 6a.

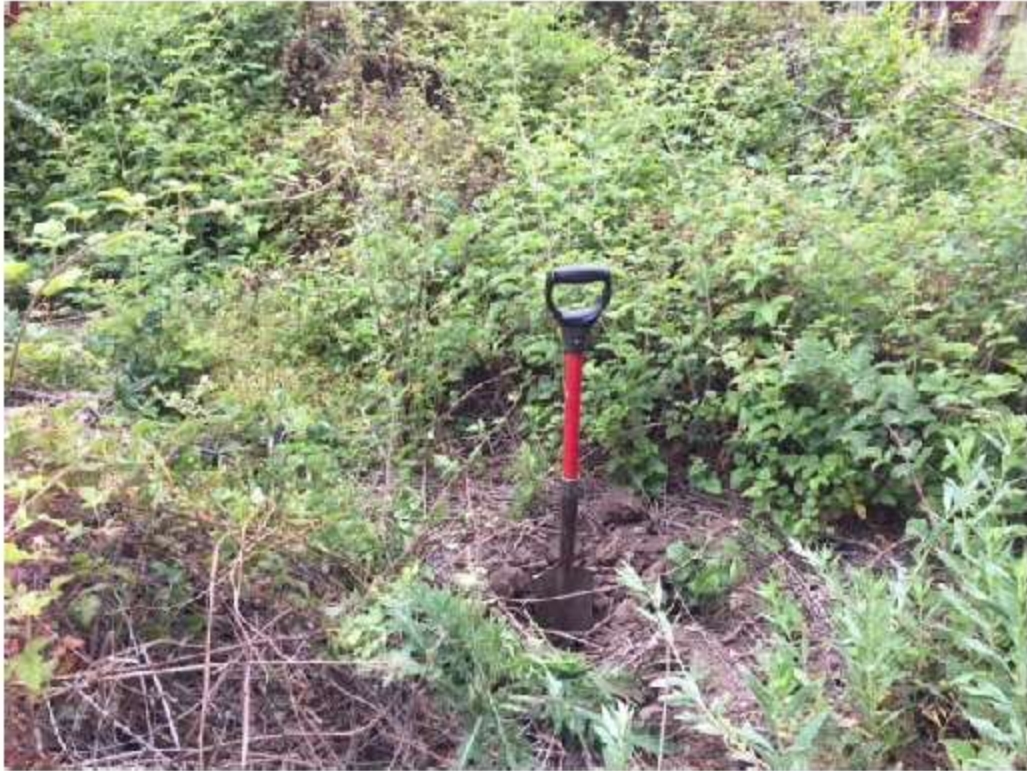
Appendix C-7. Area dominated by California blackberry, but lacking positive indicators of all three wetland parameters, at Sample Point 7.

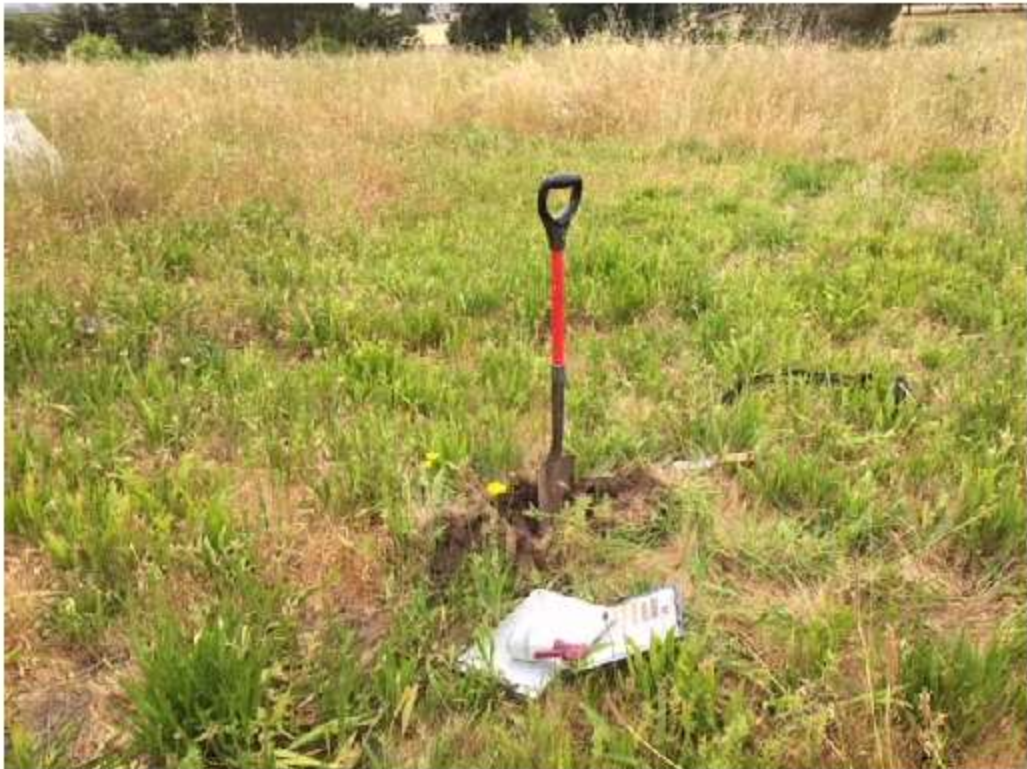
Appendix C-8. Compacted area from past disturbance at Sample Point 9.

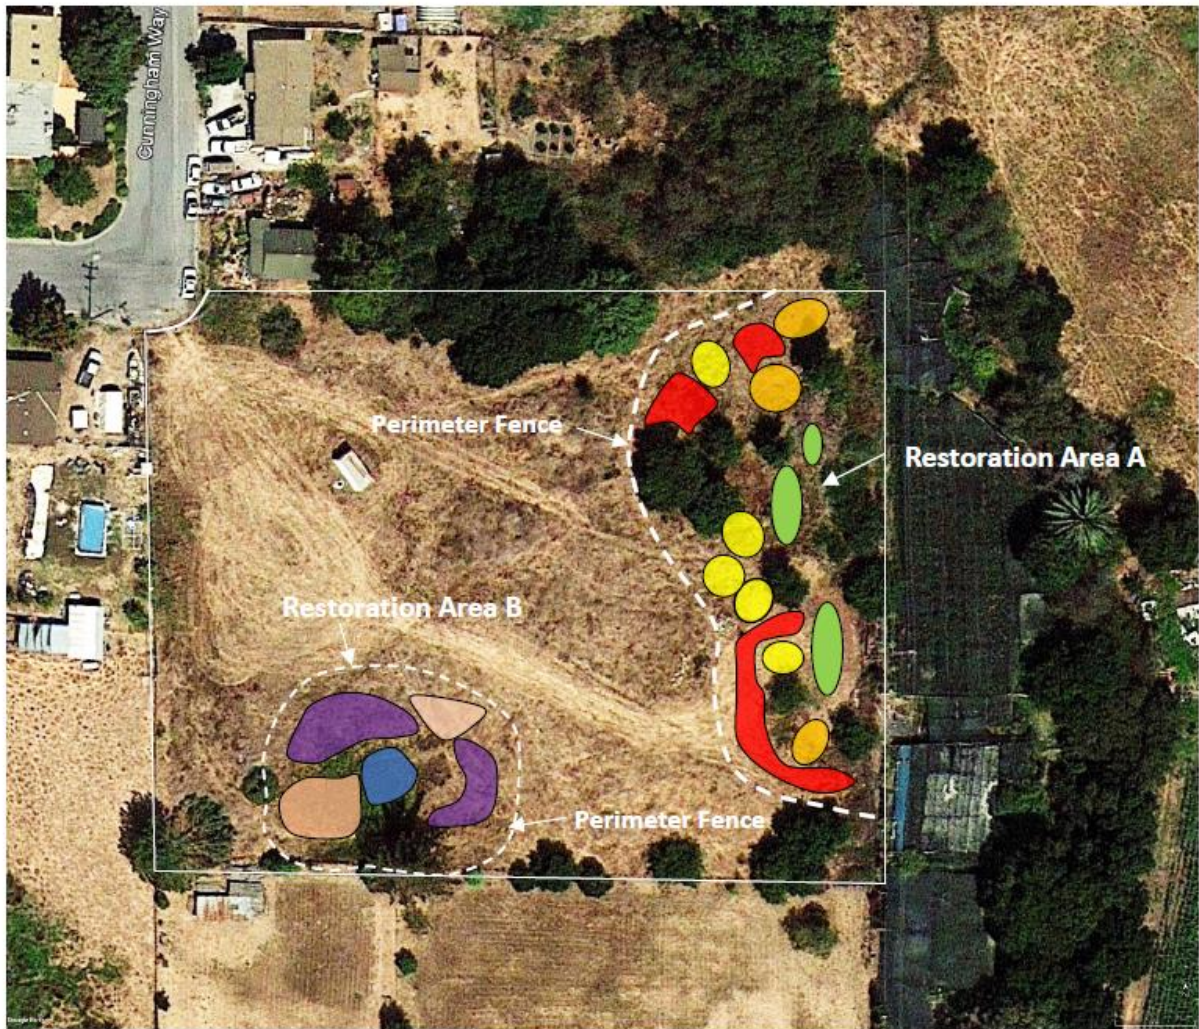
Figure 3. Conceptual Revegetation Within Revegetation Areas

Restoration Area A	
●	Coast Live Oak
●	Box Elder
●	Restoration Area A Shrub Mix
●	Willows
Restoration Area B	
●	Spreading Rush
●	California Aster
●	California Rose

Map Code Figure 3	Common Name	Scientific Name	Propagule Size	Approx. Spacing	Number of Plants
RESTORATION AREA A					
SASP	Willow	<i>Salix lasiolepis</i>	Dormant cuttings/stakes	4"	30
QUAG	Coast Live Oak	<i>Quercus agrifolia</i>	5 gal.	20'	5
QUAG	Coast Live Oak	<i>Quercus agrifolia</i>	1 gal.	20'	5
ACNE	Box Elder	<i>Acer negundo</i>	5 gal.	20'	4
ACNE	Box Elder	<i>Acer negundo</i>	1 gal.	20'	4
Shrub Mix					
FRCA	Coffee Berry	<i>Frangula californica</i>	1 gal.	6'	8
SYAL	Snowberry	<i>Symphoricarpos albus</i>	1 gal.	6'	8
RISA	Flowering Currant	<i>Ribes sanguineum</i>	1 gal.	6'	8
ROCA	California Rose	<i>Rosa californica</i>	1 gal.	5'	8
TOTAL RESTORATION AREA A					80
RESTORATION AREA B					
JUPA	Spreading Rush	<i>Juncus patens</i>	1 gal.	3'	20
SYCH	California Aster	<i>Symphotrichum chilense</i>	1 gal.	6'	25
ROCA	California Rose	<i>Rosa californica</i>	1 gal.	5'	12
TOTAL RESTORATION AREA B					57

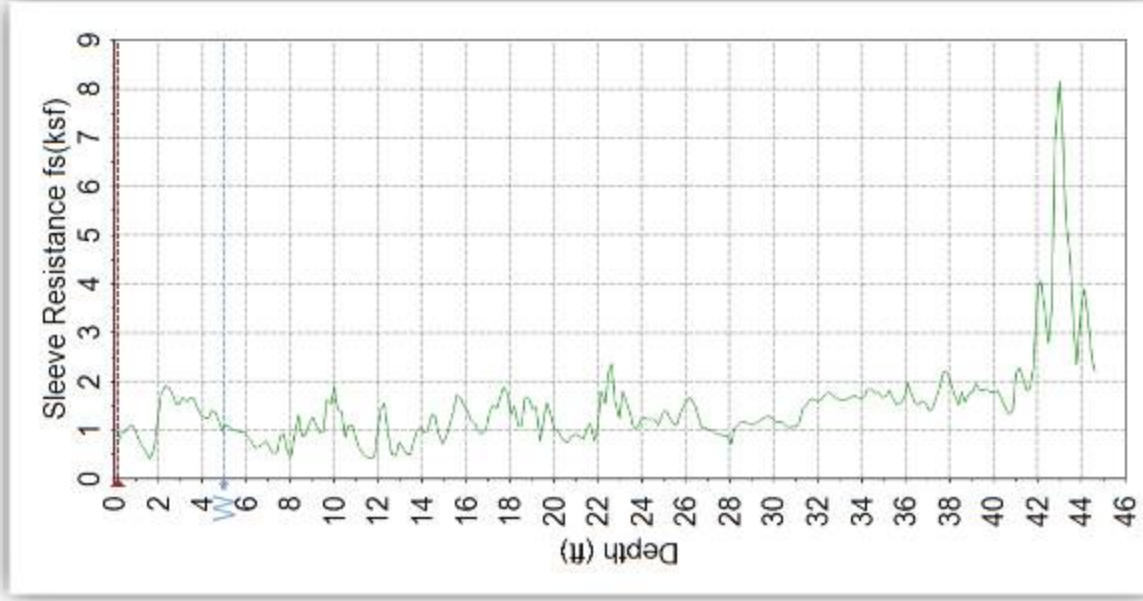
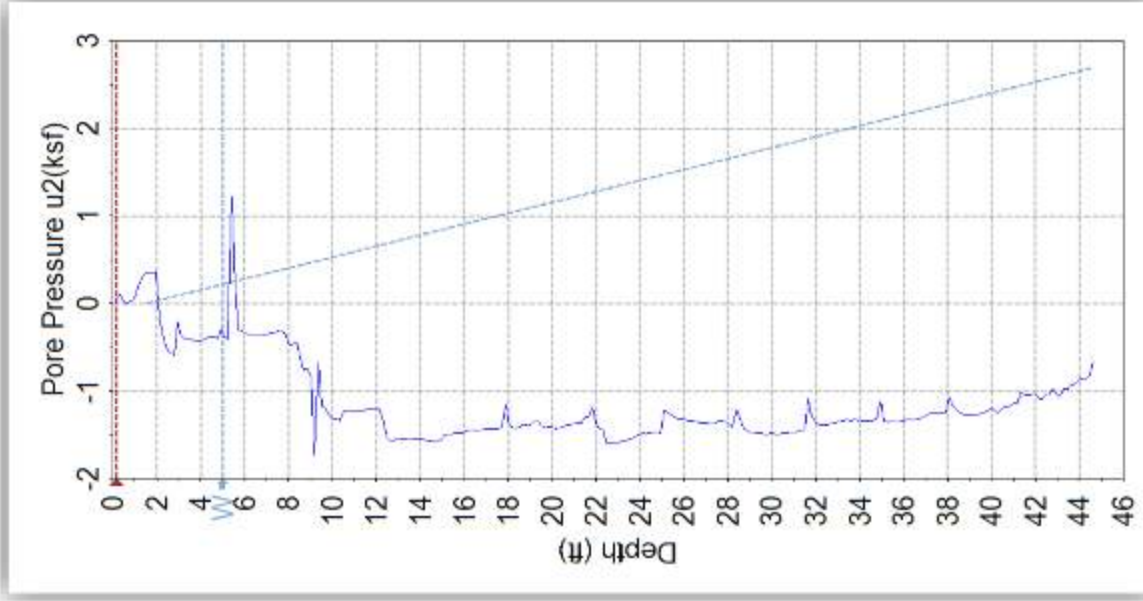
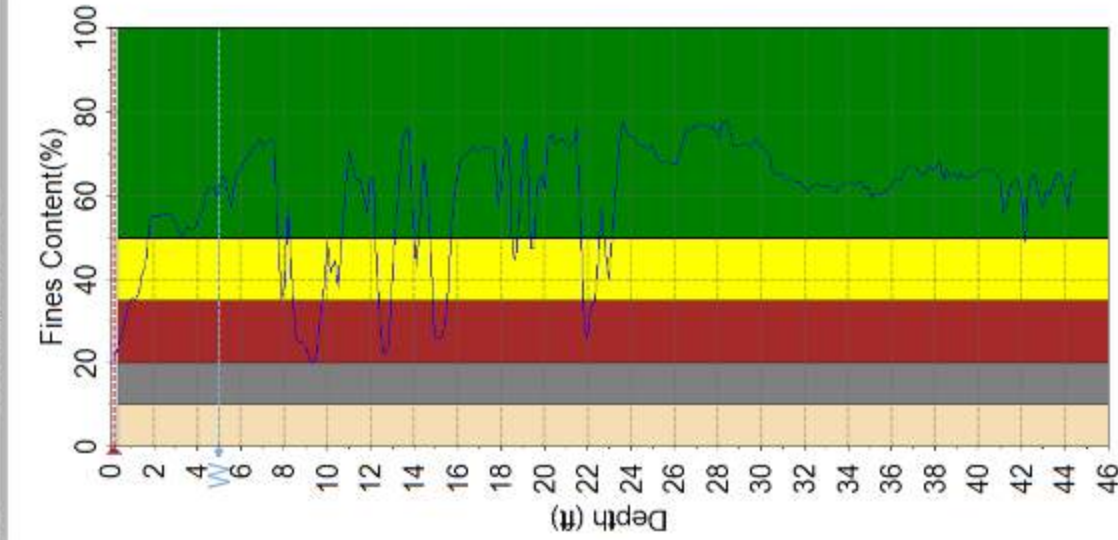
CPT LOGS

Groundwater Level: 5 Feet

Cone Area Ratio: 0.8

- 1. Sensitive Fines
- 2. Organic Material
- 3. Clay
- 4. Silty Clay to Clay
- 5. Clayey Silt to Silty Clay
- 6. Sandy Silt to Clayey Silt
- 7. Silty Sand to Sandy Silt
- 8. Gravelly Sand to Sand
- 9. Sand and silty sand
- 10. Very Stiff Fine-Grained
- 11. Sand
- 12. Sand to Clayey Sand

- a. Perched groundwater was encountered during the course of our field exploration at approximately 5 feet below the existing grade, at its closest elevation to the ground surface. The groundwater was observed to be traveling through sandier strata throughout our borings. Groundwater and wet conditions are noted on the boring and CPT logs, **Figures A-3 through A-13**.

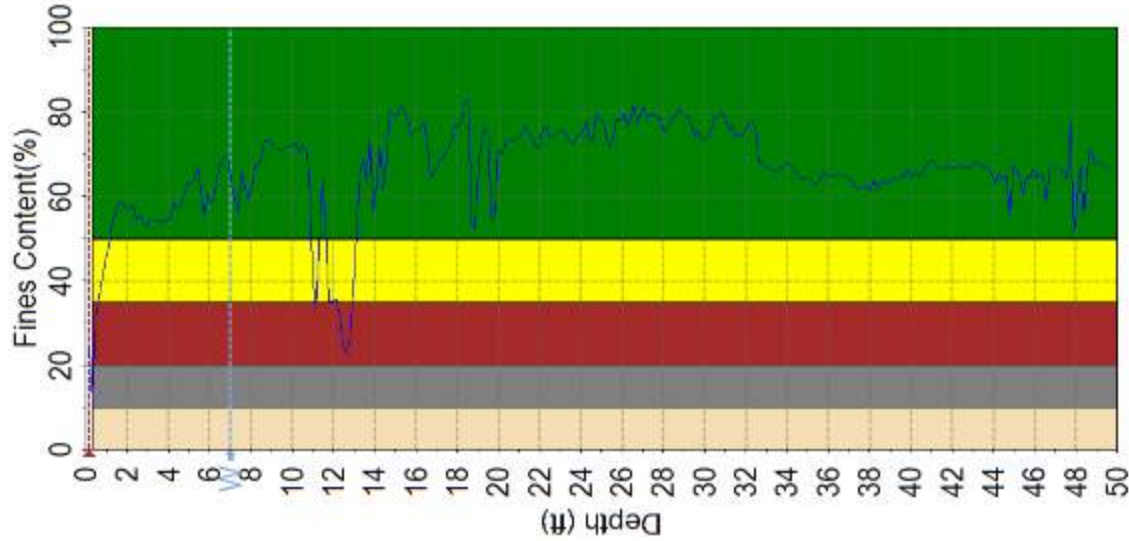
CPT LOGS

Groundwater Level: 7 Feet

Cone Area Ratio: 0.8

- 1. Sensitive Fines
- 2. Organic Material
- 3. Clay
- 4. Silty Clay to Clay
- 5. Clayey Silt to Silty Clay
- 6. Sandy Silt to Clayey Silt
- 7. Silty Sand to Sandy Silt
- 8. Gravelly Sand to Sand
- 9. Sand and Silty Sand
- 10. Very Stiff Fine-Grained
- 11. Sand to Clayey Sand
- 12. Sand

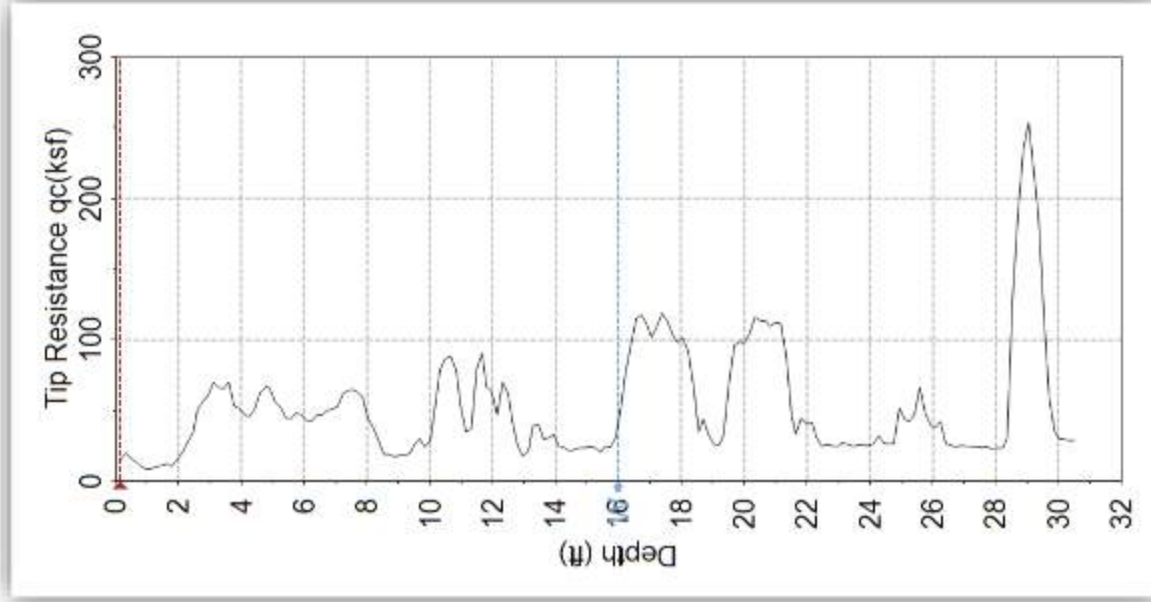
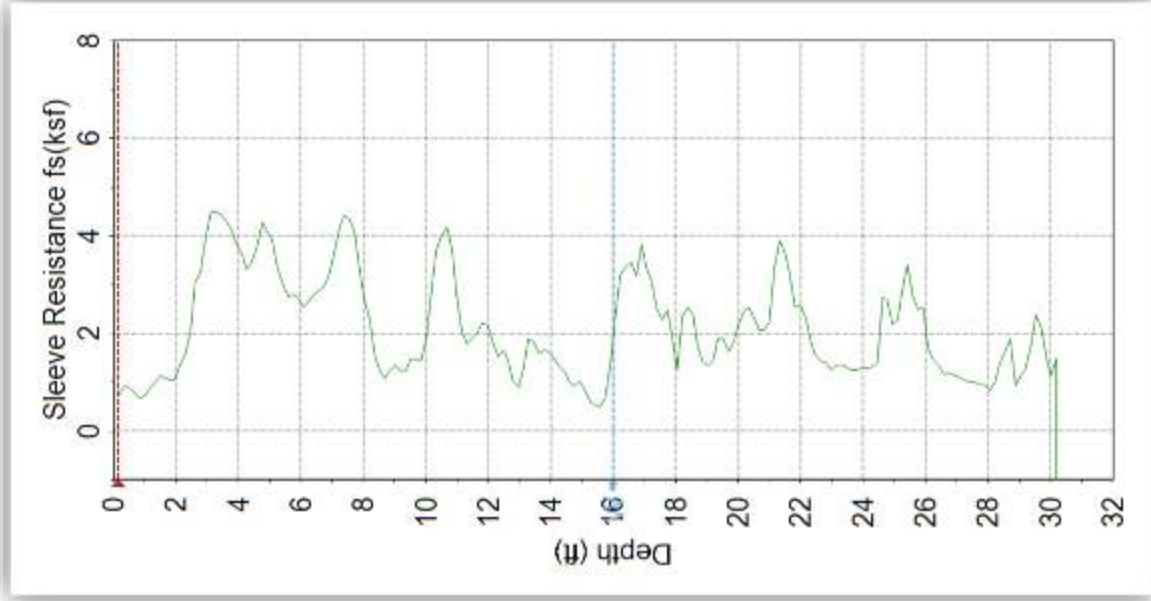
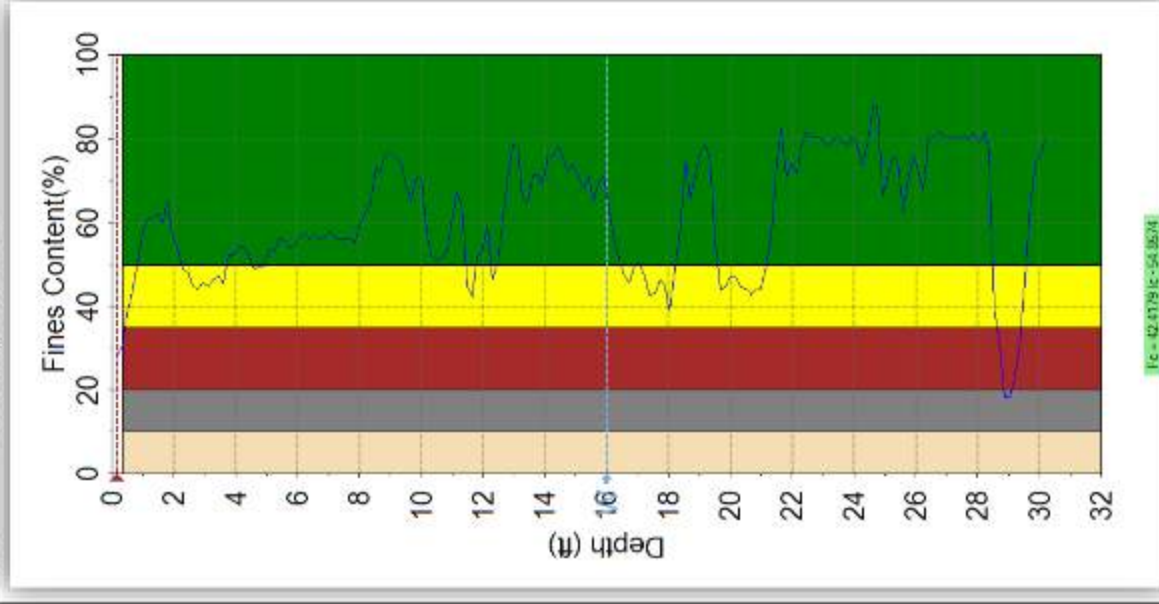
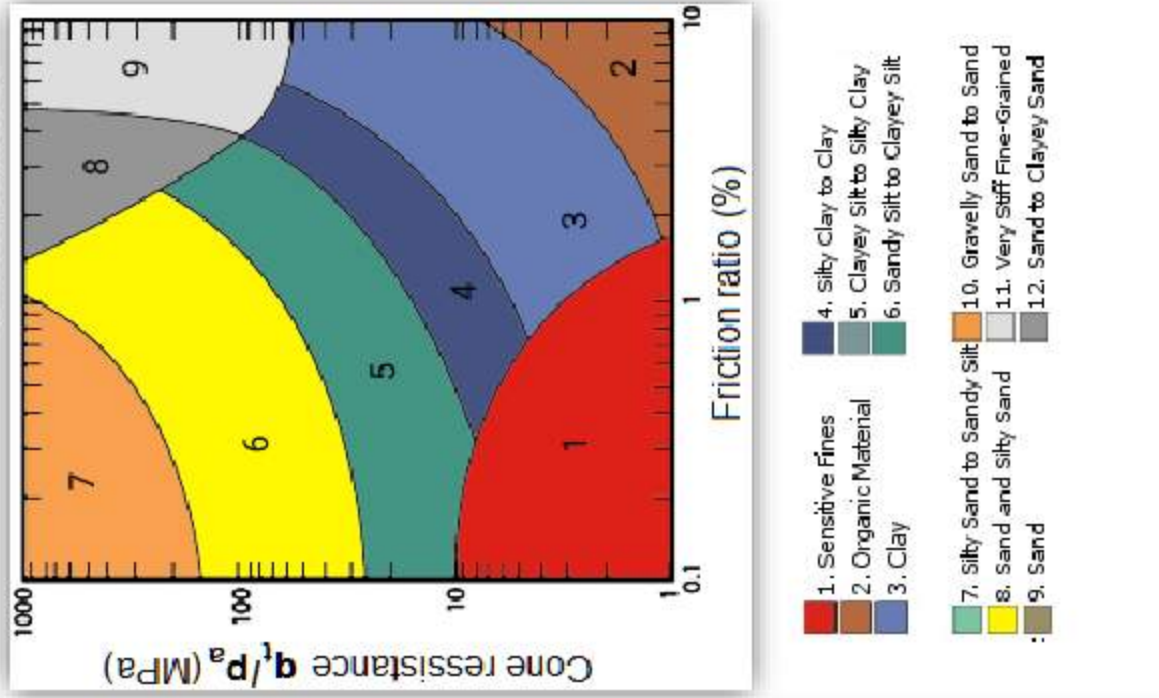
CPT LOGS

Groundwater Level: 16 Feet

Cone Area Ratio: 0.8

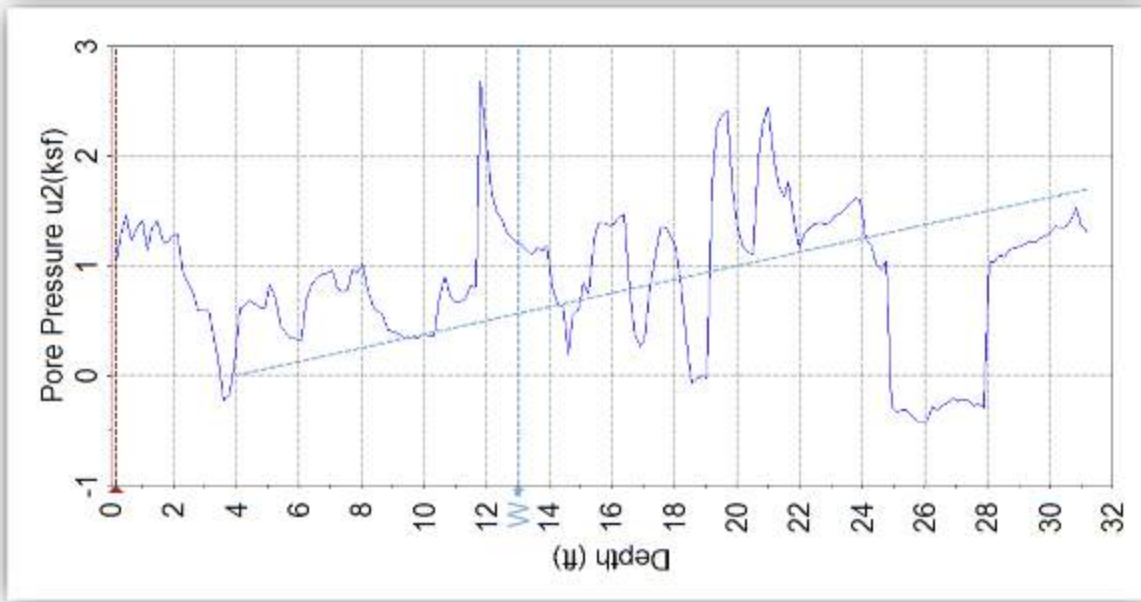
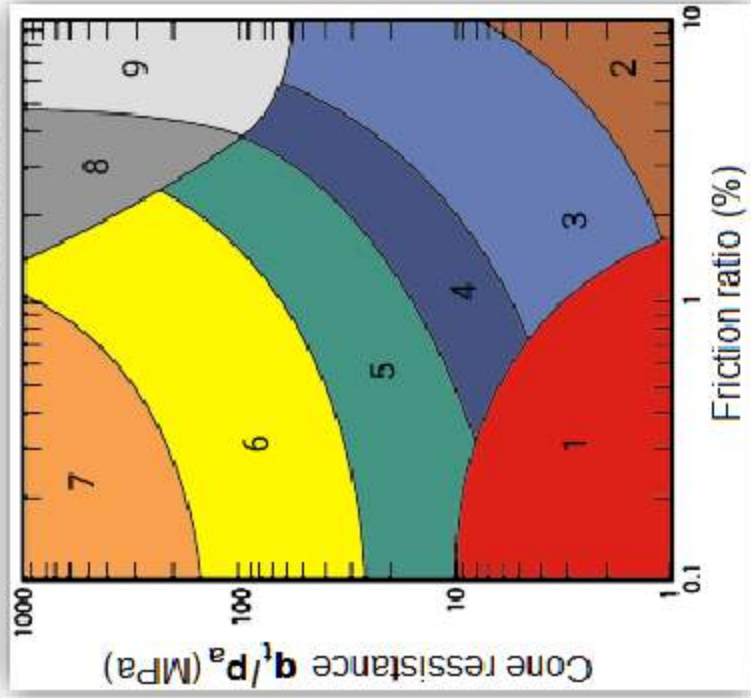
Groundwater Level: 13 Feet

Cone Area Ratio: 0.8

- 1. Sensitive Fines
- 2. Organic Material
- 3. Clay
- 4. Silty Clay to Clay
- 5. Clayey Silt to Silty Clay
- 6. Sandy Silt to Clayey Silt
- 7. Silty Sand to Sandy Silt
- 8. Sand and silty Sand
- 9. Sand
- 10. Gravelly Sand to Sand
- 11. Very Stiff Fine-Grained
- 12. Sand to Clayey Sand

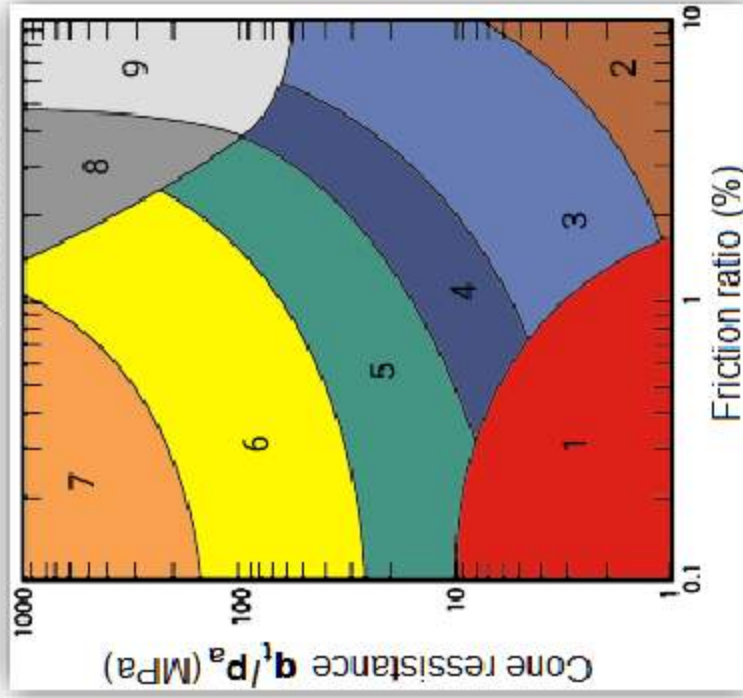
Robertson 1986 (S&S)

- 1. Sensitive Fines
- 2. Organic Material
- 3. Clay
- 4. Silty Clay to Clay
- 5. Clayey Silt to Silty Clay
- 6. Sandy Silt to Clayey Silt
- 7. Silty Sand to Sandy Silt
- 8. Sand and silty Sand
- 9. Sand
- 10. Gravelly Sand to Sand
- 11. Very Stiff Fine-Grained
- 12. Sand to Clayey Sand

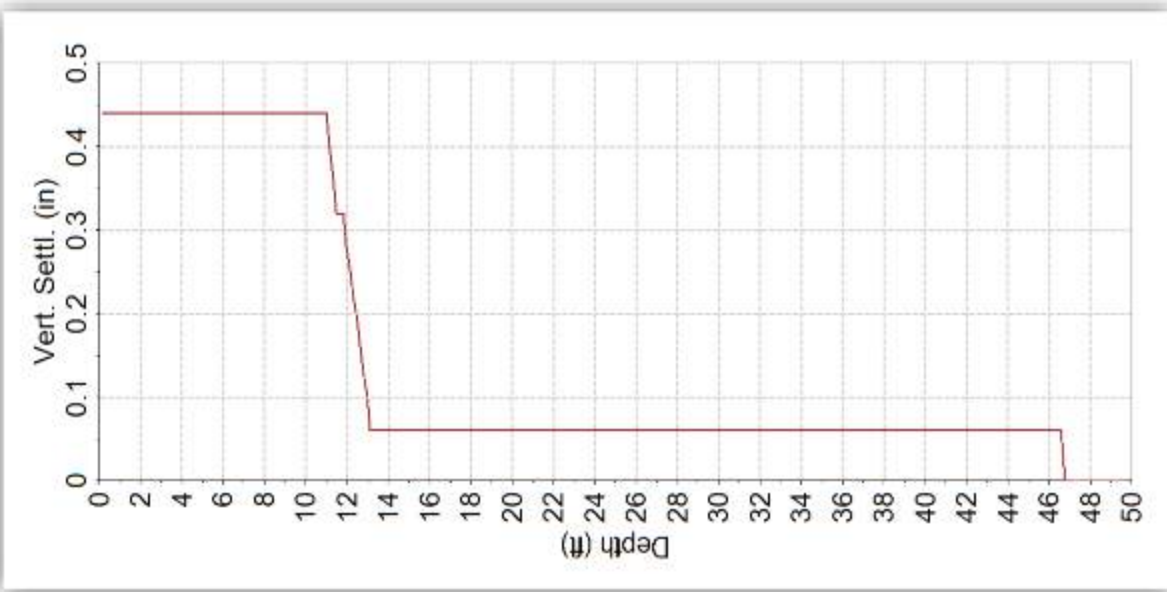
LIQUEFACTION RESULTS

Trembley Lane, Watsonville

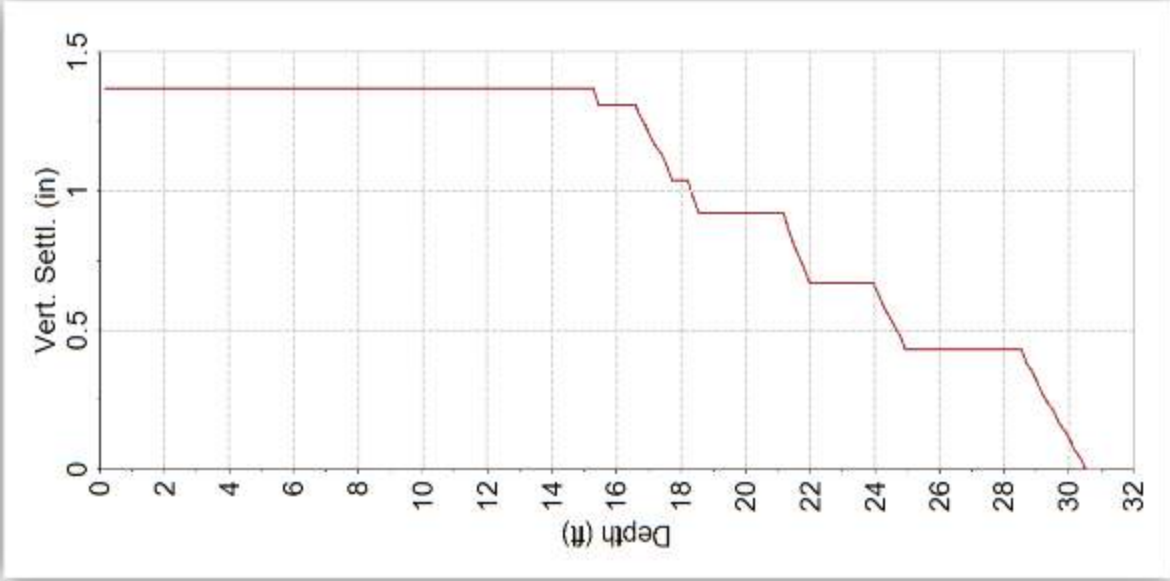
FIGURE
B-4.2

Groundwater Level: 13 Feet

LIQUEFACTION RESULTS
Trembley Lane, Watsonville
