AQUATIC RESOURCE DELINEATION REPORT

LAKEVIEW ESTATES (APN 051-411-20)
WATSONVILLE, SANTA CRUZ COUNTY, CALIFORNIA

MAY 2018

Tom Mahony, MS, PWS
Certified Professional Wetland Scientist #2567
Coast Range Biological LLC
PO Box 1238
Santa Cruz, CA 95061
(831) 426-6226
coastrange@sbcglobal.net

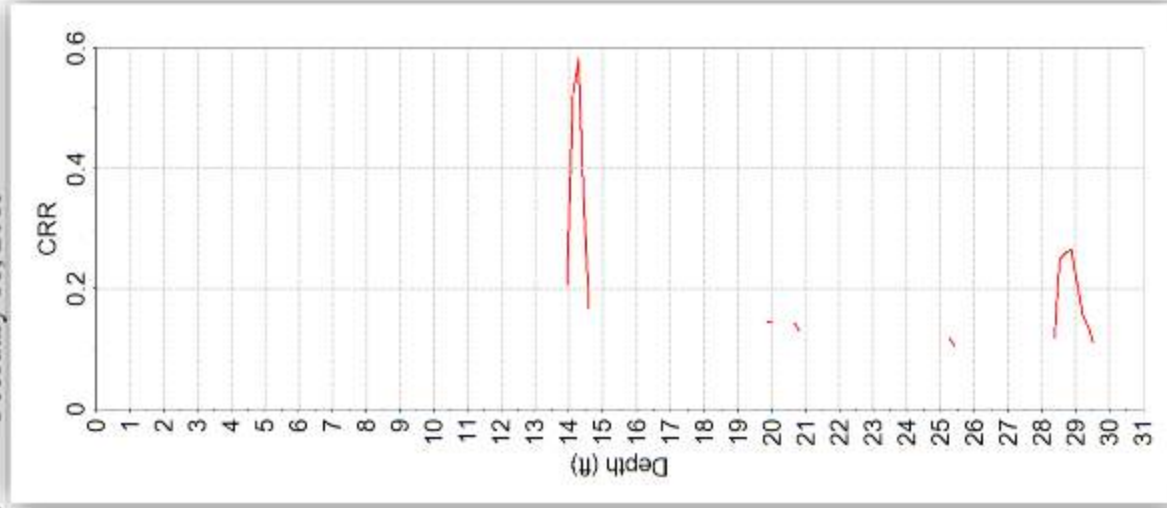
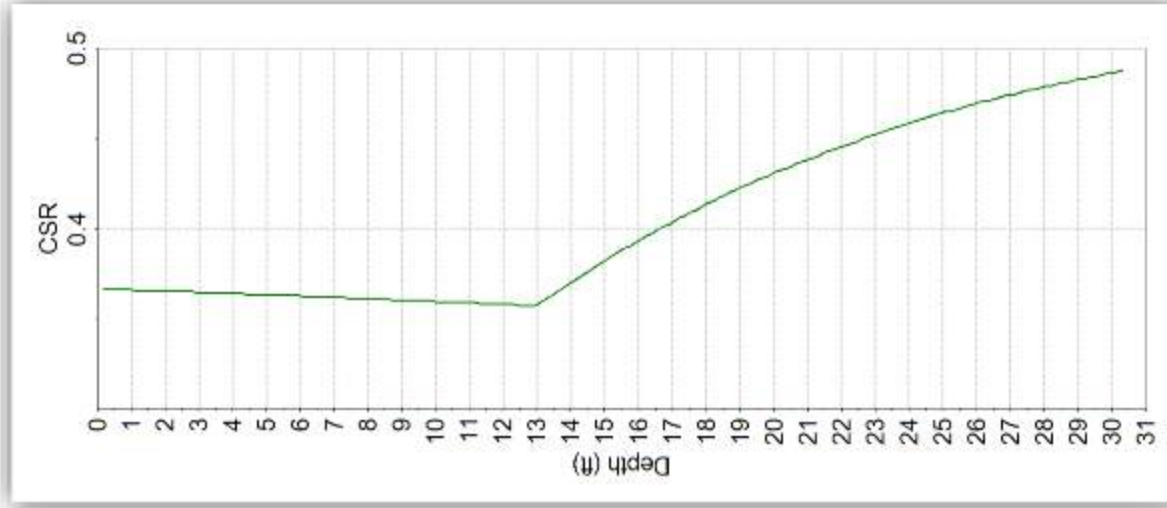
Borehole No: CPT-6

Groundwater Level: 13 Feet

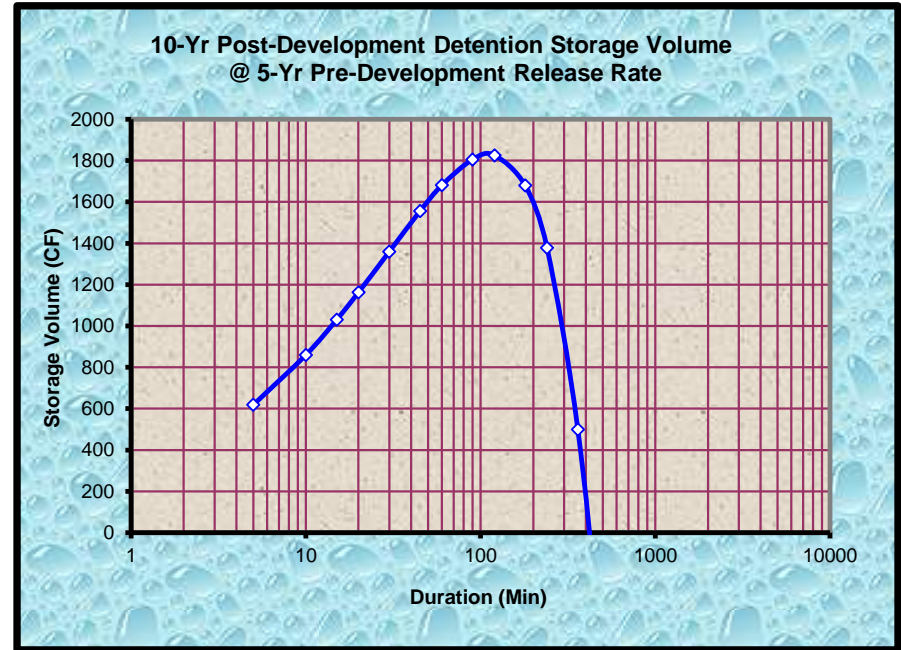
10 - YEAR DESIGN STORM				DETENTION @ 15 MIN.	
Storm Duration (min)	10 - Year Intensity (in/hr)	5 - Yr. Release Qpre (cfs)	10 - Year Qpost (cfs)	Detention Rate To Storage (cfs)	Specified Storage Volume (cf)
1440	0.23	0.039	0.165	-0.118	-12732
1200	0.25	0.042	0.179	-0.104	-9385
960	0.28	0.046	0.197	-0.086	-6199
720	0.32	0.053	0.223	-0.060	-3234
480	0.38	0.063	0.266	-0.017	-609
360	0.43	0.071	0.302	0.018	499
240	0.51	0.085	0.360	0.077	1378
180	0.58	0.096	0.407	0.124	1679
120	0.69	0.115	0.486	0.203	1825
90	0.78	0.130	0.551	0.267	1806
60	0.93	0.155	0.656	0.373	1681
45	1.05	0.176	0.744	0.461	1555
30	1.26	0.209	0.887	0.604	1359
20	1.50	0.250	1.058	0.775	1162
15	1.70	0.283	1.199	0.916	1030
10	2.03	0.338	1.429	1.146	860
5	2.74	0.456	1.932	1.649	618

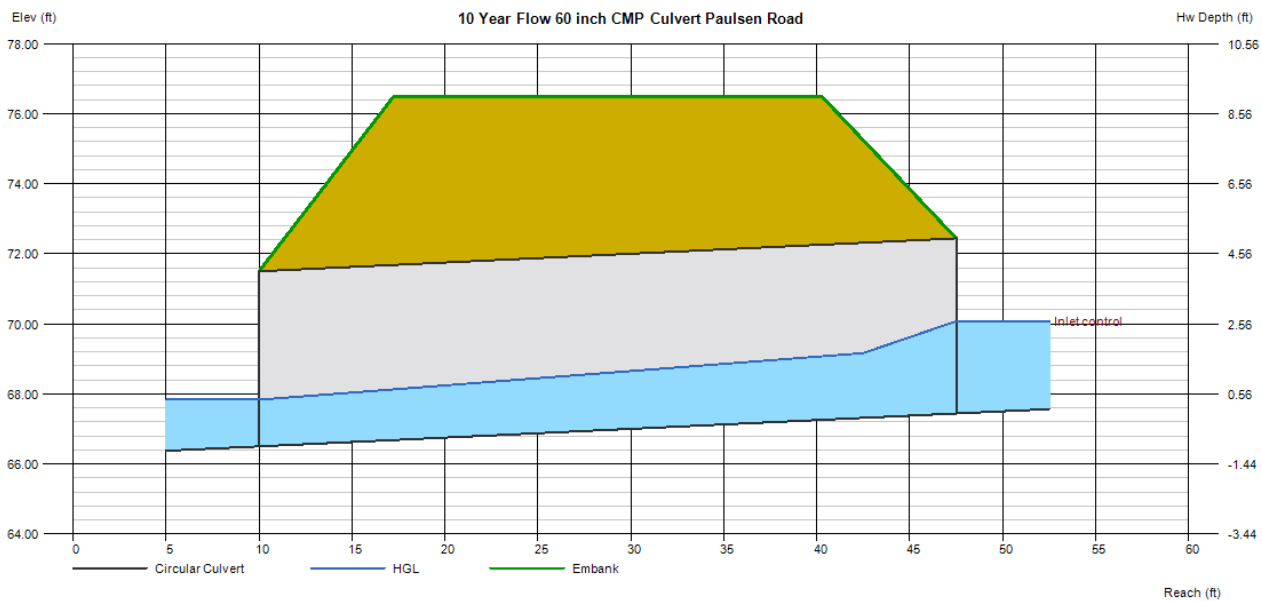
Calculations	
Qmin (cfs)	= 47.60
Qmax (cfs)	= 47.60
Tailwater Elev (ft)	= Normal

Highlighted	
Qtotal (cfs)	= 47.60
Qpipe (cfs)	= 47.60
Qovertop (cfs)	= 0.00
Veloc Dn (ft/s)	= 11.33
Veloc Up (ft/s)	= 6.81
HGL Dn (ft)	= 67.83
HGL Up (ft)	= 69.37
Hw Elev (ft)	= 70.07
Hw/D (ft)	= 0.53
Flow Regime	= Inlet Control
